ESTABLISHMENT AND TESTING OF A  
RADIO TELEMETRY SYSTEM

A Thesis  
Submitted to  
the Division of Biological Sciences  
Emporia Kansas State College, Emporia, Kansas

by  
Thomas A. Hutton  
August, 1975

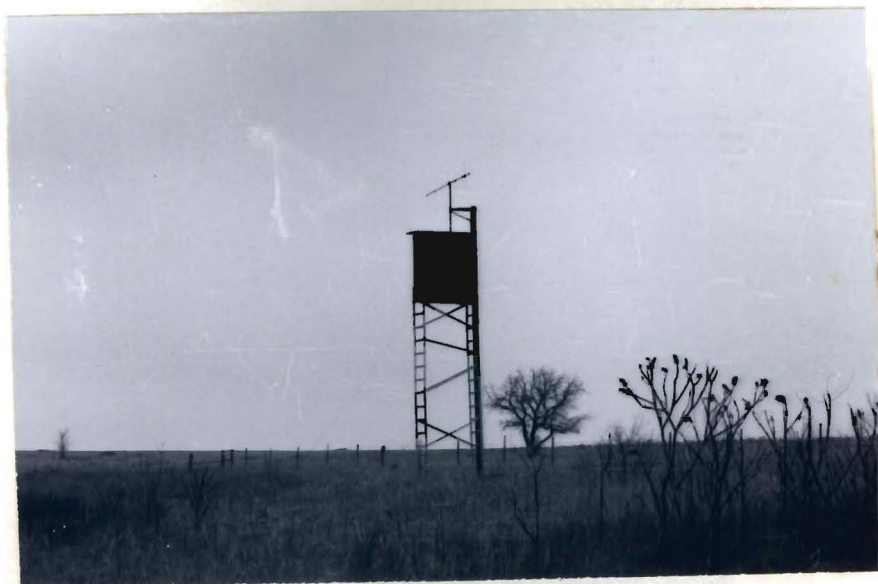
Fig. 1. Receiver Station One.

Two permanent receiver sites were constructed on elevated points at RNHR. A utility pole was set at each site by the Kansas Power and Light Company to serve as the main support for the antenna mast. A scaffold was erected beside each utility pole to allow maintenance and adjustment of the antenna. Station One (Fig. 1) is located directly north of the headquarters building along the northern boundary of the state-owned property (Appendix A, S1). A wooden shelter was constructed on top of the scaffold to provide minimal protection from the elements and to serve as an observation post. A compass rose was mounted on a table inside of the shelter. The antenna was 30 feet high and was mounted on a 1½ inches x

11 feet mast that passed through the roof of the shelter and the compass rose table, and was seated in a base plate on the floor of the shelter.

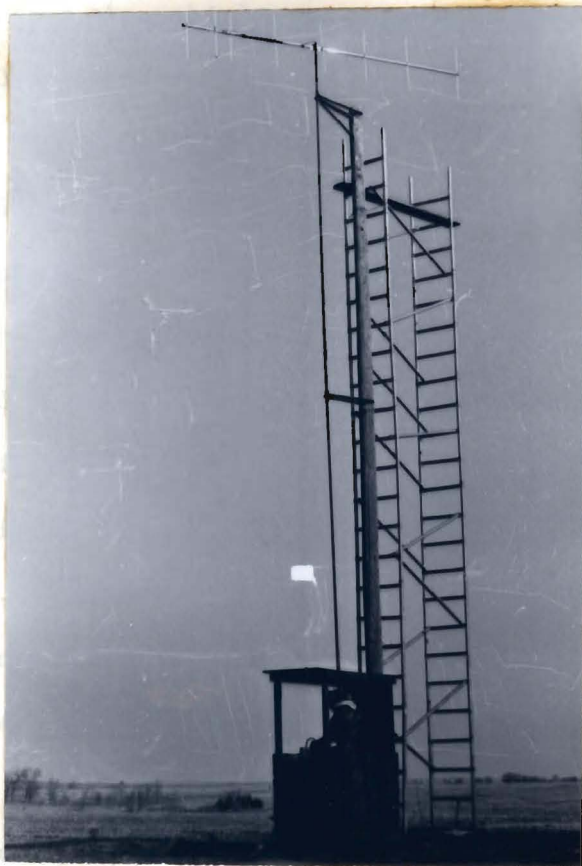
Fig. 2. Receiver Station Two.

Station Two (Fig. 2) was located immediately west of the headquarters building (Appendix A, S2). The antenna was 38 feet high. Its mast passed through the roof and compass rose table of a shelter at the base of the utility pole. Both receiver sites had a length of coaxial cable running inside of the mast from the antenna to the shelter.

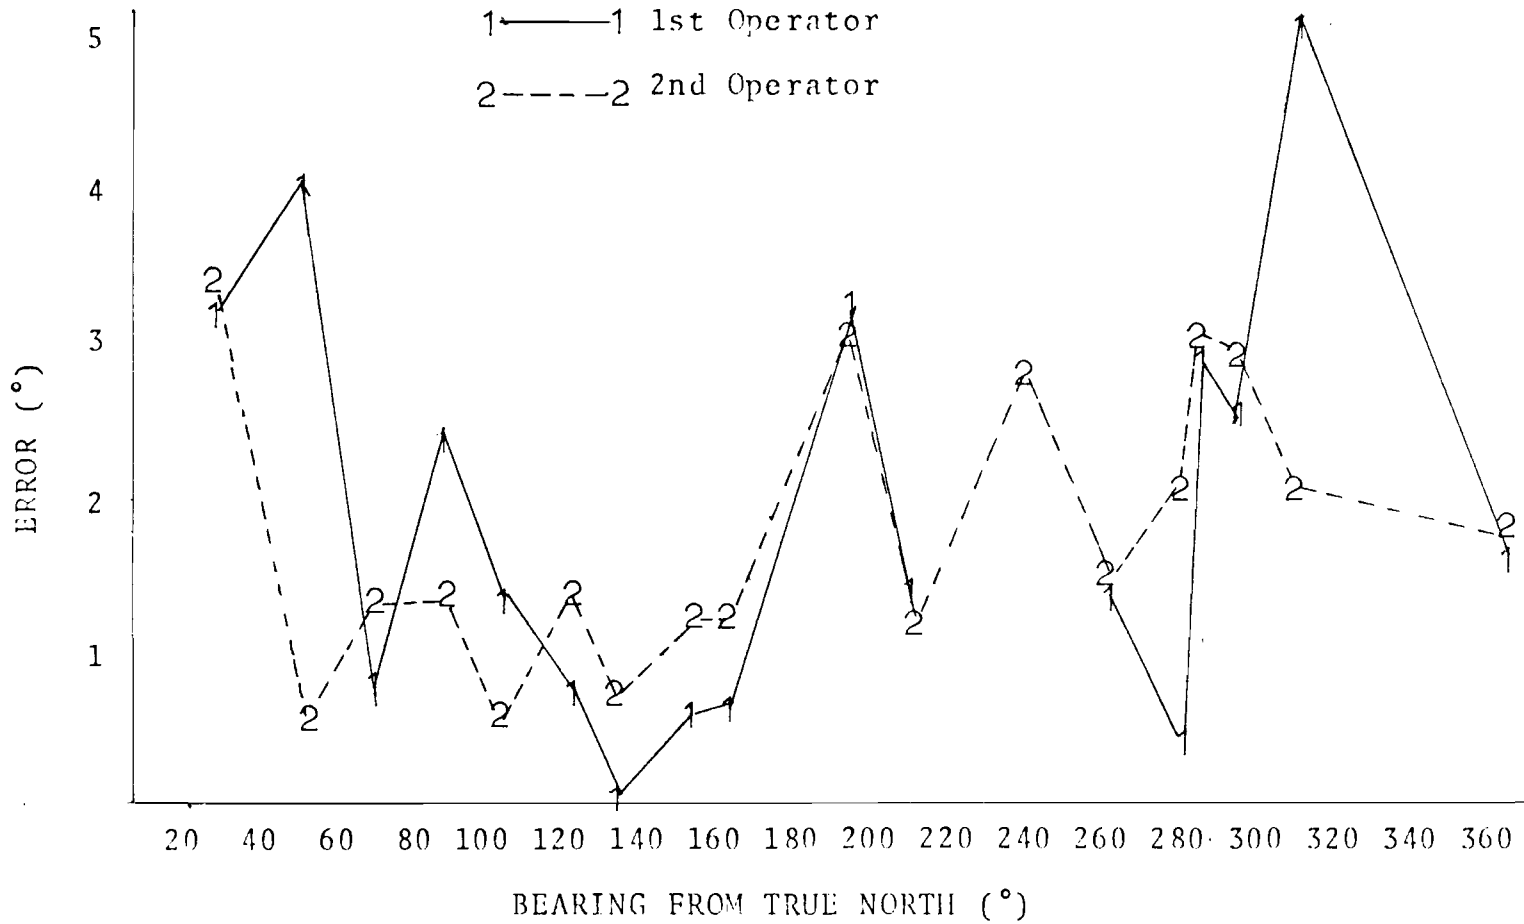
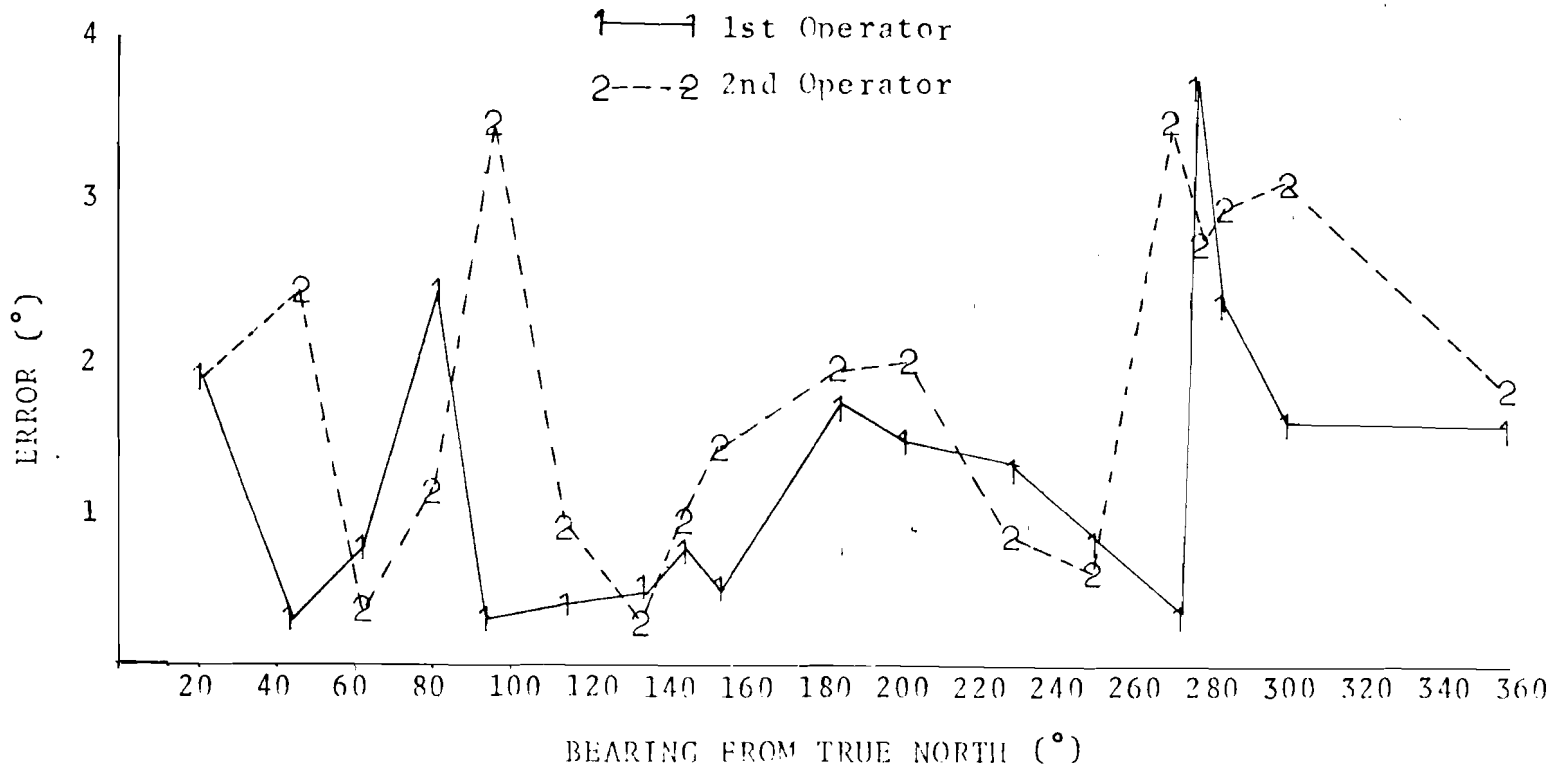
Figures 10 and 11 represent each operator's error for each transmitter site from Station One on October 8 and 9, 1974.

Figure 10. Each operator's error for each transmitter site from Station One on October 8, 1974.

Figure 11. Each operator's error for each transmitter site from Station One on October 9, 1974.

Overall, error from Station One was greater than error from Station Two. There were no large trees around Station One that could have caused the error. Although there are several exceptions, the operators had generally the same error for each transmitter site. During the trials on Station One, no attempt was made to orient the transmitter's antenna in the same plane as the receiving antenna. It has since been learned that if the receiving antenna is set up for receiving vertical polarization and the transmitter antenna is oriented horizontally, signal maximums and minimums may be obtained in unpredictable directions (Anonymous, No date). This might explain the inconsistency in error between operators (Fig. 10 & 11).
