**Reactivated Paleokarst in Northern Audrain County,
Missouri**

A Thesis

Master of Science

James Blake Smotherman

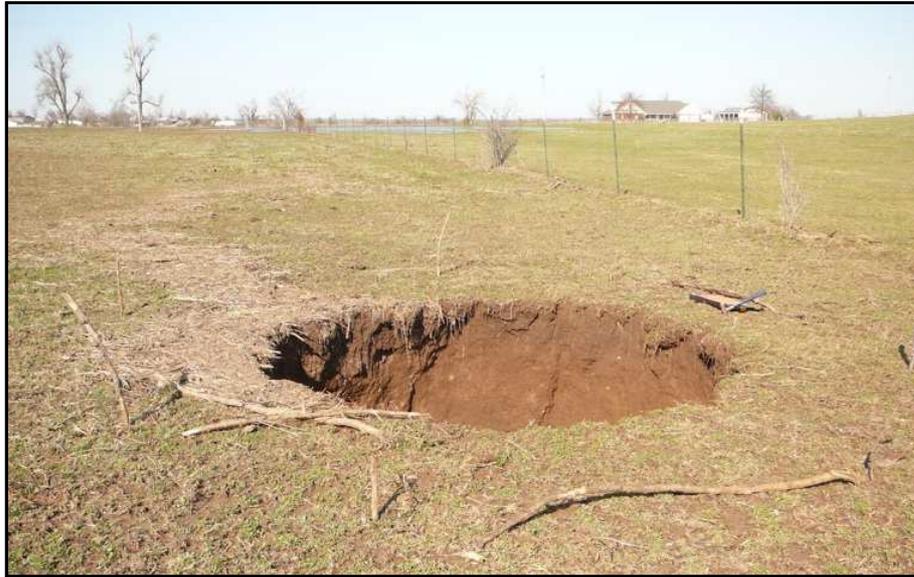
Figure 2.1 An example of a typical sinkhole in southwest Missouri. Circular void is propagating from a bedrock fracture approximately 6.1 meters (20 feet) deep. Residual clay is seen at the rim of the sinkhole.

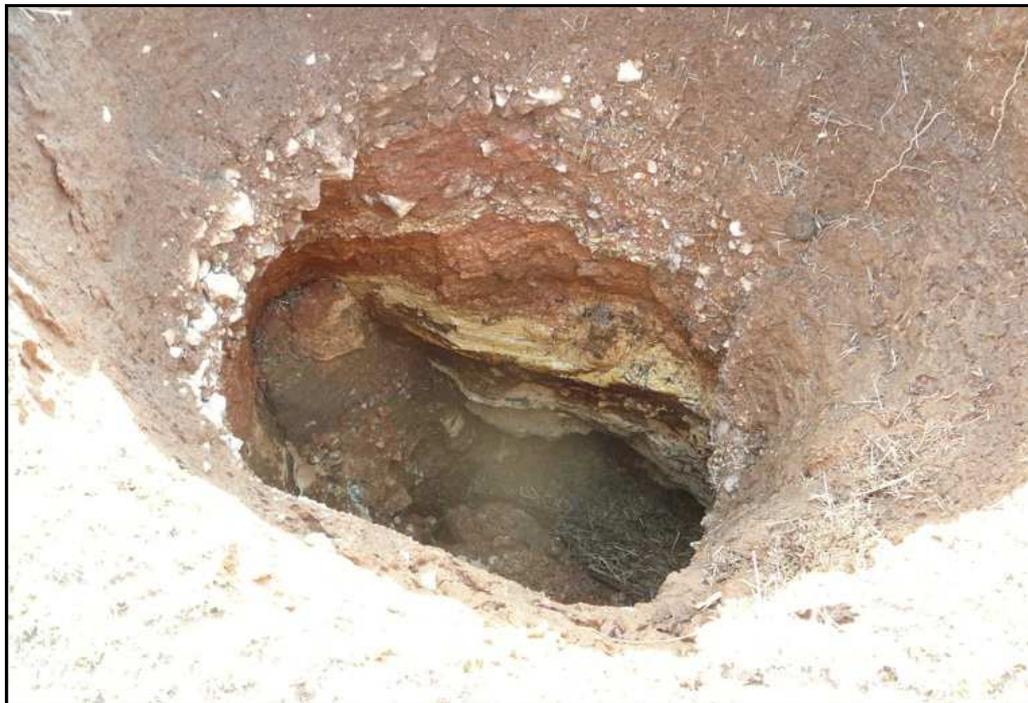
Figure 2.2 Sinkhole from Figure 2.1 viewed from the edge. The solution-enlarged fracture is in dolomite bedrock. Note the residual gravels near the top of bedrock. Water was heard moving through the sinkhole when the photo was taken.

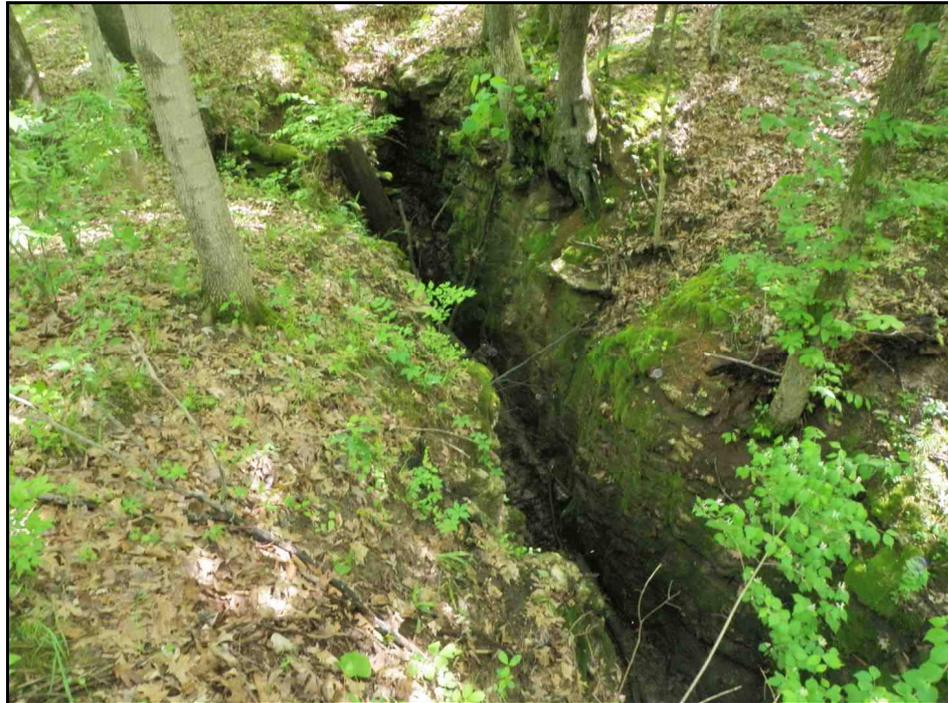
Figure 2.3 Example of a solution-enlarged fracture, St. Louis, Missouri. The fracture is approximately 4.6 meters (15 feet) deep.

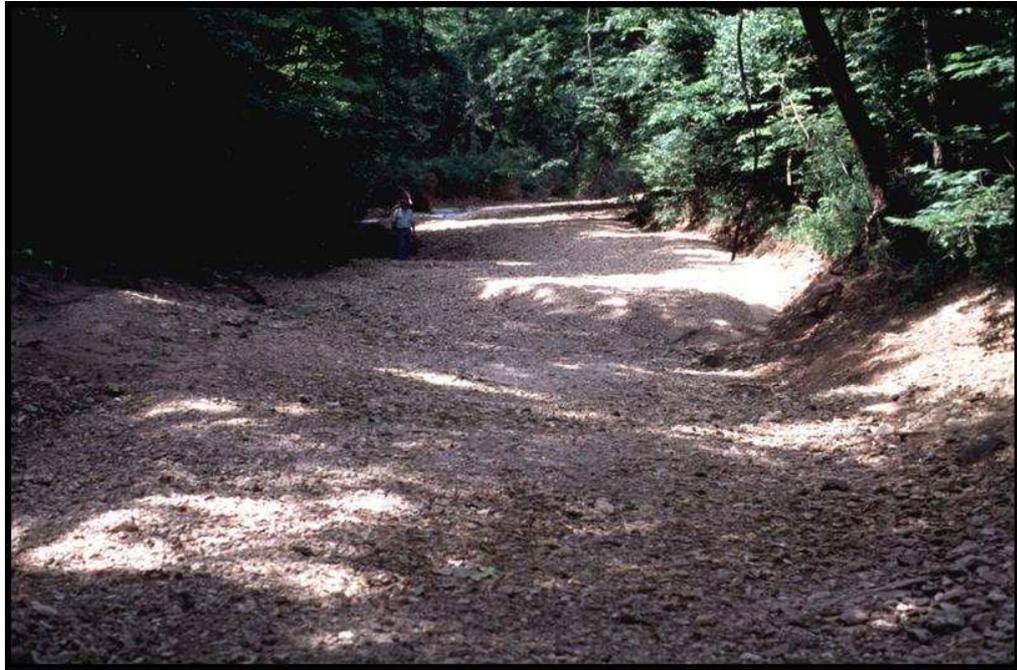
Figure 2.5 Schluersburg Karst Chasm after filling in with chert gravel from flooding in the losing stream channel the following spring.

Figure 2.5 shows the same location during the following spring, with stream gravels filling the previously open solution-widened fracture.

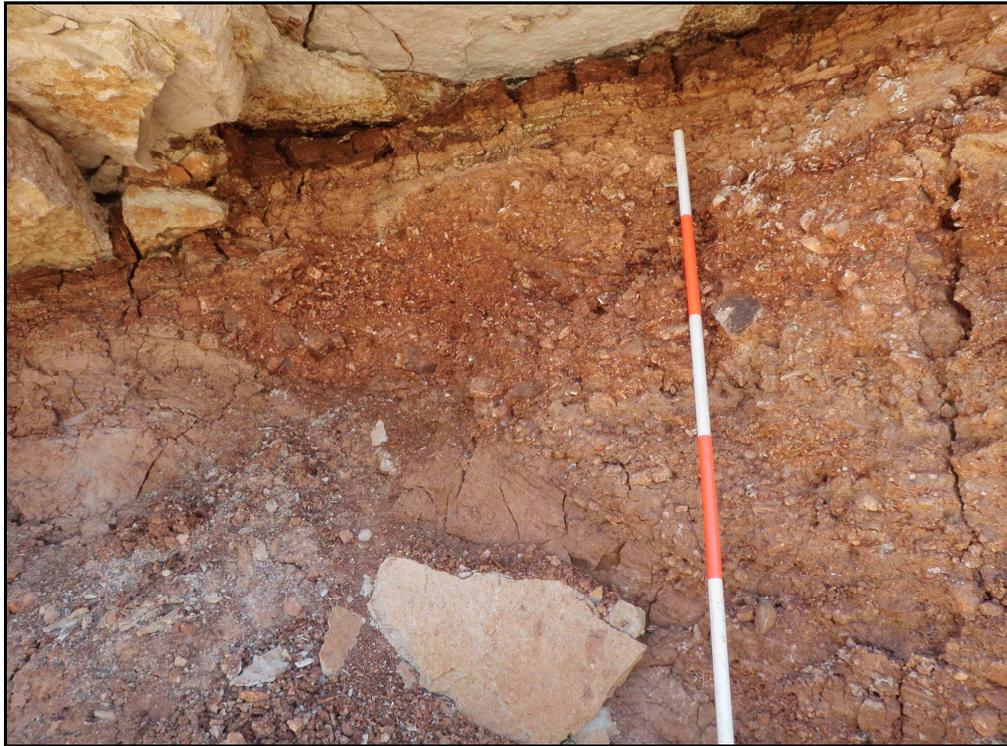
Figure 2.8 Example of stratified paleofill from paleokarst deposit near Branson Airport, southern Missouri.

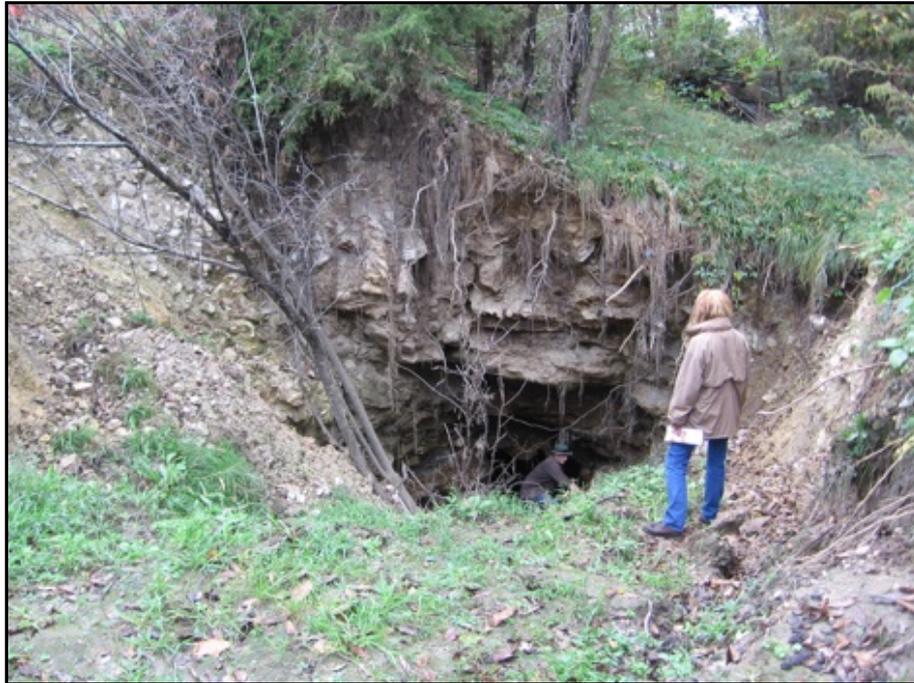
Figure 4.2 Paleosink 1 in 2008. The author (green hat) is standing at the entrance. The observer is approximately 6.1 meters (20 feet) away. The observer in the foreground is standing in Fracture 1.

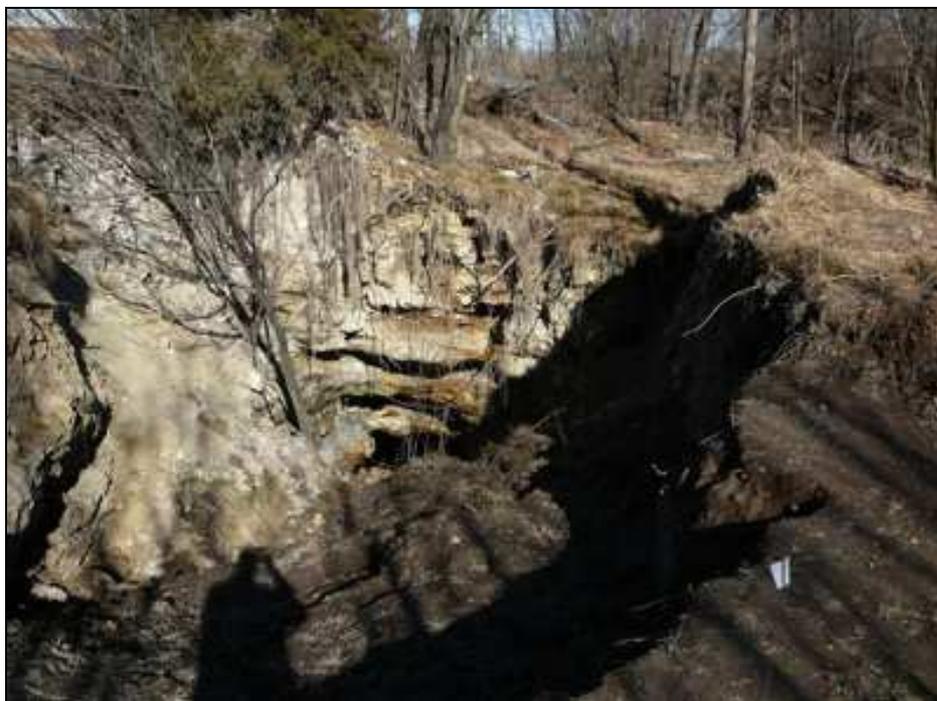
Figure 4.3 Paleosink 1 and Fracture 1 in 2009. Photo facing to the east.

In 2009 and 2011, Paleosink 1 experienced continued expansion at its opening, as was observed by the addition of fresh chert and clay breakdown on the slope that leads into the swallet of the paleosink (Figure 4.3). Fracture 1 (discussed below) was also observed to have subsided almost 0.91 meters (3 feet) in depth, as well as extending an additional 1.52 to 1.82 meters (5 to 6 feet) (Figure 4.4).

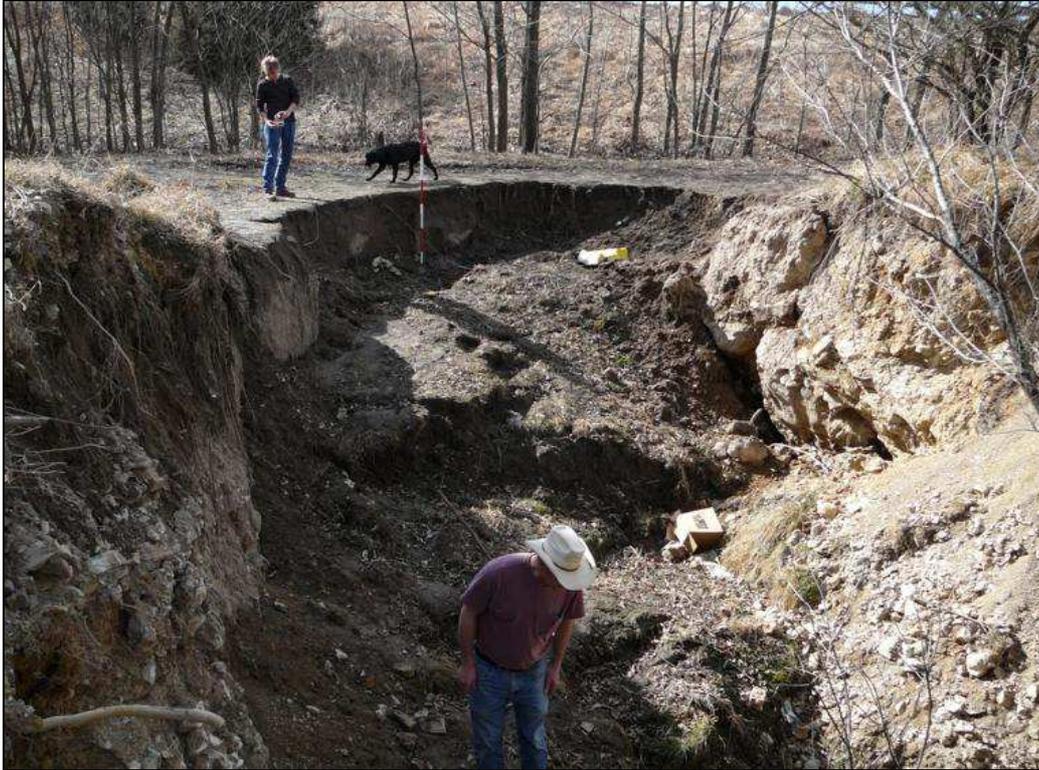
Figure 4.4 Fracture 1 in 2009. Photo taken from above entrance to Paleosink 1. A new subsidence scarp 1.31 meters (4.3 feet) had formed since 2008 (see Jacob's staff next to black labrador retriever).

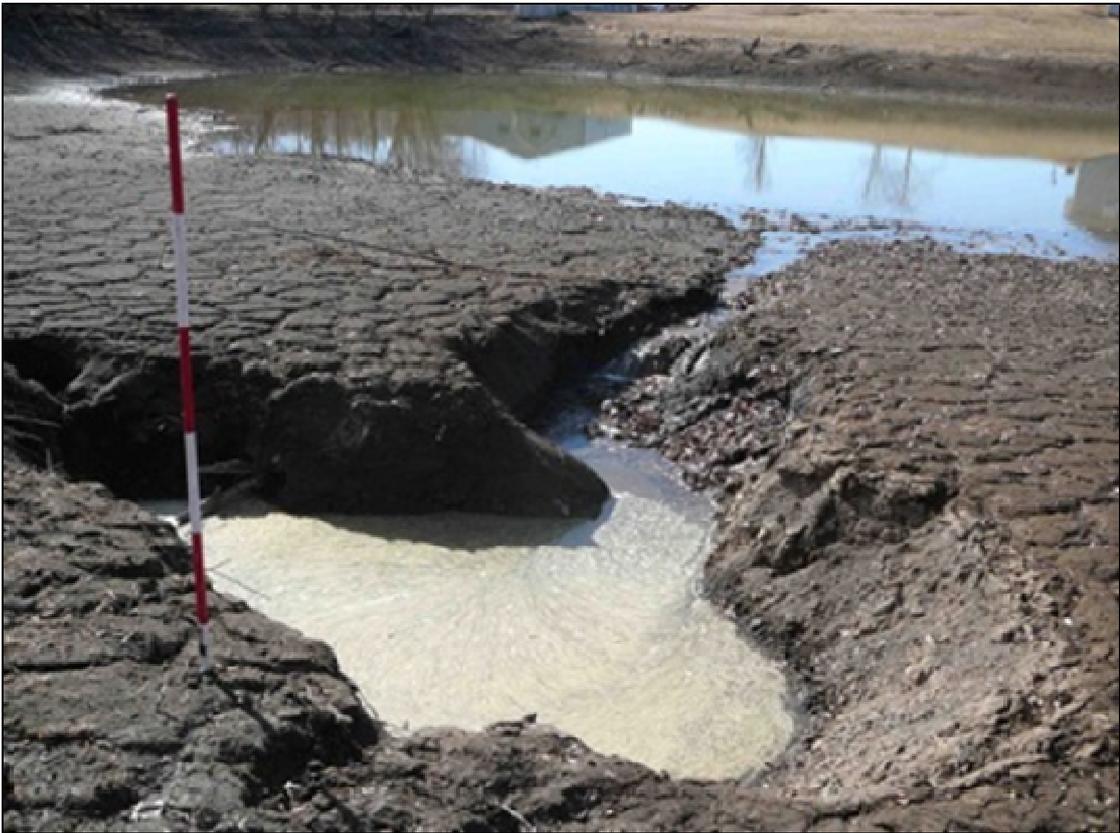
Figure 4.5 Paleosink 2 as it was draining the lake in 2008. Water is flowing from the lakebed into the sinkhole. Photo facing southwest.

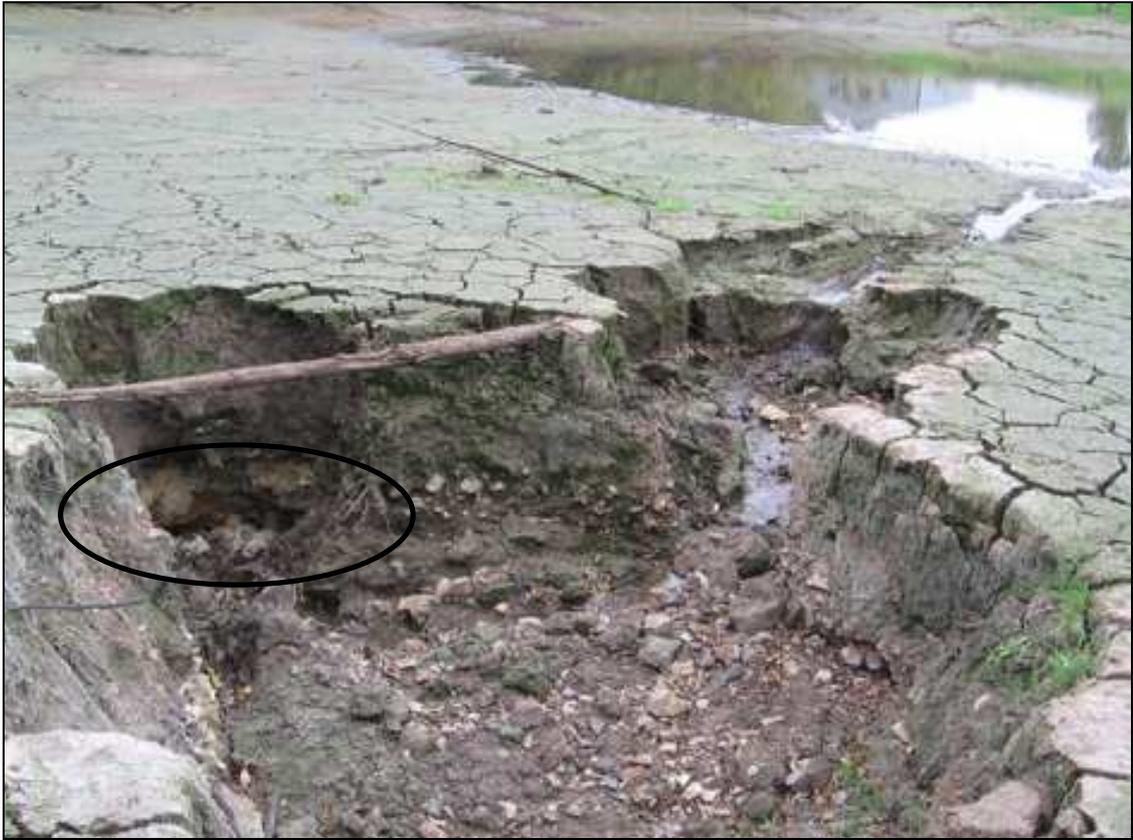
Figure 4.6 Paleosink 2 in 2009. The black oval encircles the swallet of the paleosink, with yellow residual clay within. Note the expansive clay fracturing in the lakebed.

sinkhole collapses occurred after an unusually dry summer, followed by the passage of Hurricane Ike in the fall of 2008. In 2009, Paleosink 2 was not taking in as much water as had been observed in 2008, but the channel that had developed along the clay of the lake bed between the lowest point in the former lake and the sinkhole indicated that it could take on additional flow from the stream during precipitation events (Figures 4.6 and 4.7).

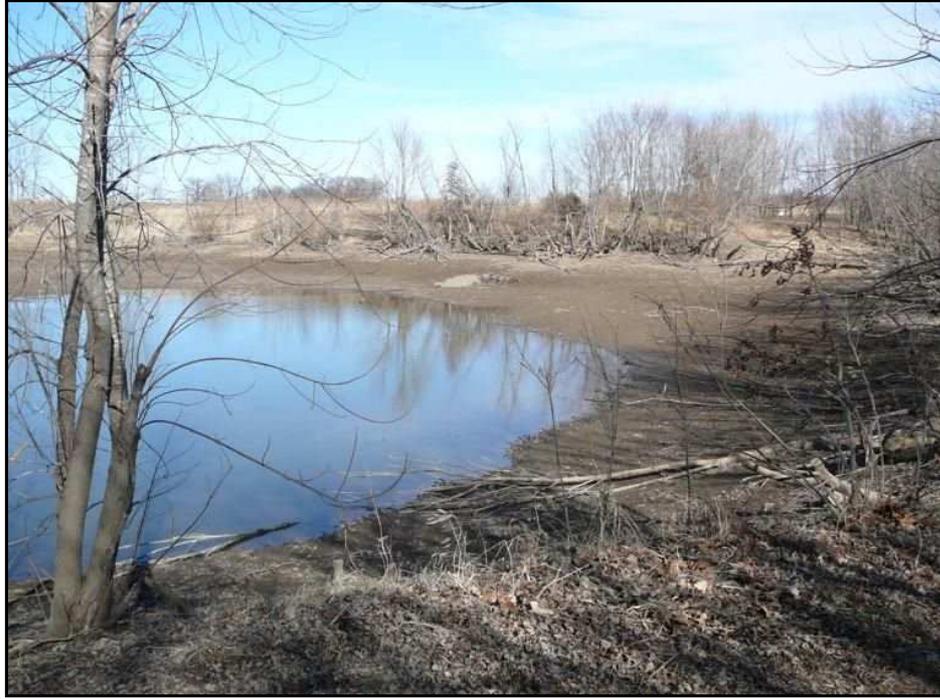
Figure 4.7 Paleosink 2 from the southwest in 2009.

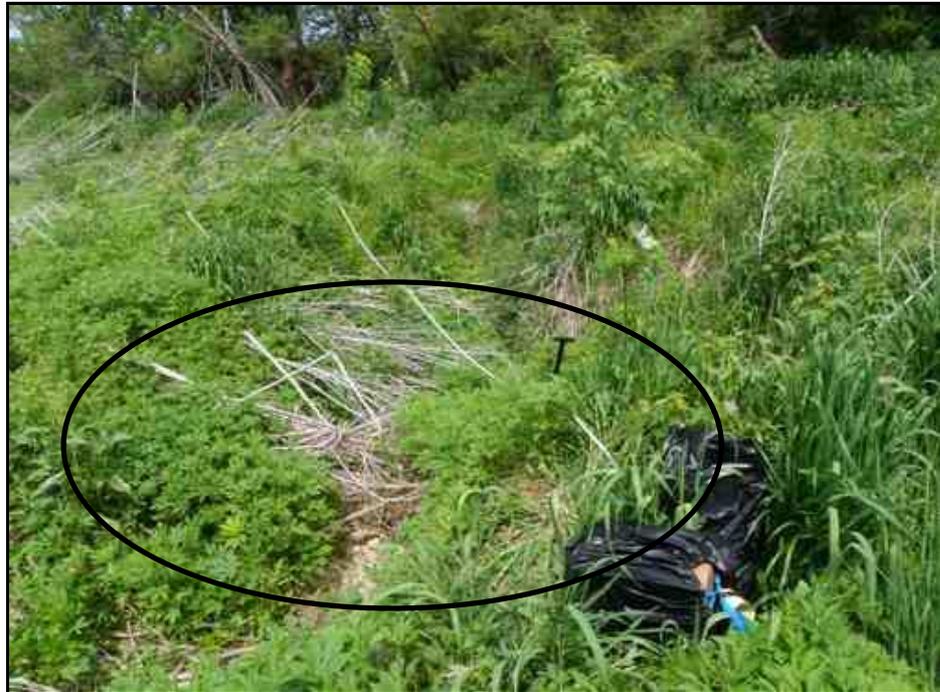
Figure 4.8 Paleosink 2 in 2011 during the dye trace. The black shovel handle is next to the swallet that is observed taking on water in the 2008 photo. The black oval is the approximate boundary of the paleosink. Photo taken facing northeast.

In 2011, the lakebed had become grown over with tall, woody vegetation (Figure 4.8). Paleosink 2 was observed to have sloughed inward, obscuring the clay and gravel eye. It also appeared to have subsided further, now appearing about 1.52 meters (5 feet) deep. In order to inject dye into the sinkhole, a 0.91-meter (3 feet) deep hole was dug to refusal.

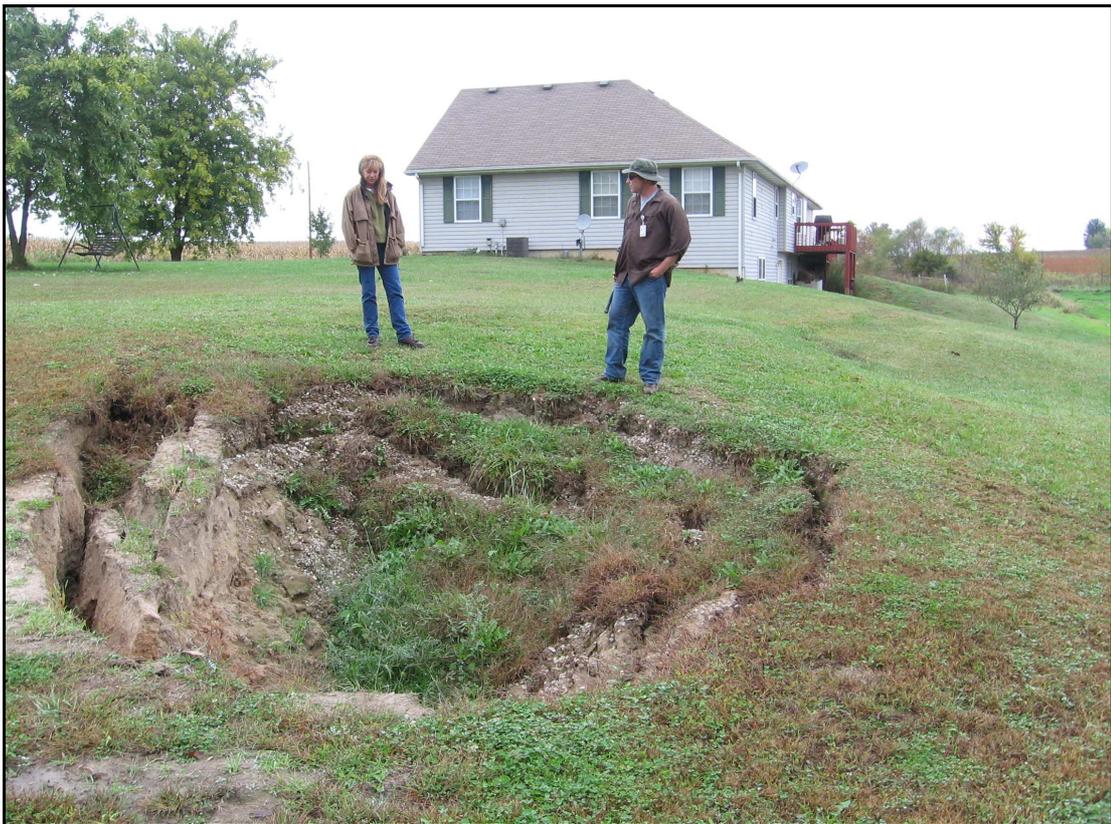
Figure 4.9 Paleosink 3 in 2008.

Paleosink 3 is 6.08 meters (20 feet) higher in elevation than the other two sinkholes, having formed on the ridge close to the landowner's home (Figure 4.1). Like the other two paleosinks, it has expanded since first being observed in 2008 (Figures 4.9 and 4.10). Paleosink 3 is observed to have a much higher percentage of sand in the surficial materials. Other investigations along the west ridge indicate that it has till with underlying sandstone residuum that was not seen during subsurface testing on the eastern ridge.

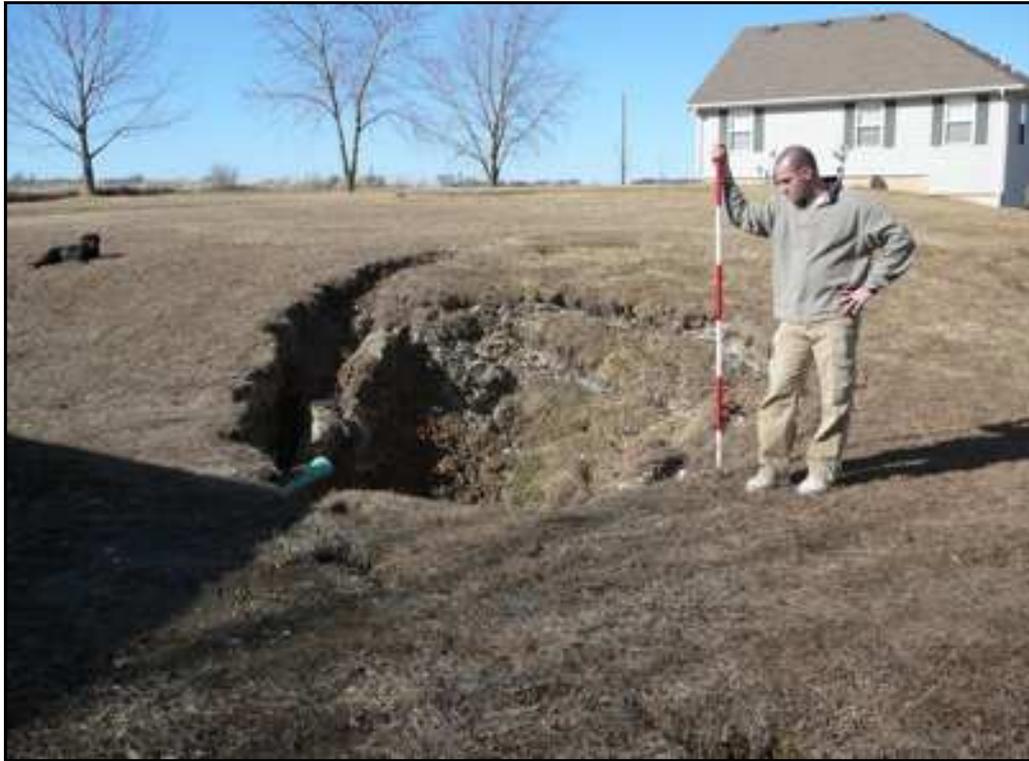
Figure 4.10 Paleosink 3 in 2009. Photo facing northwest.

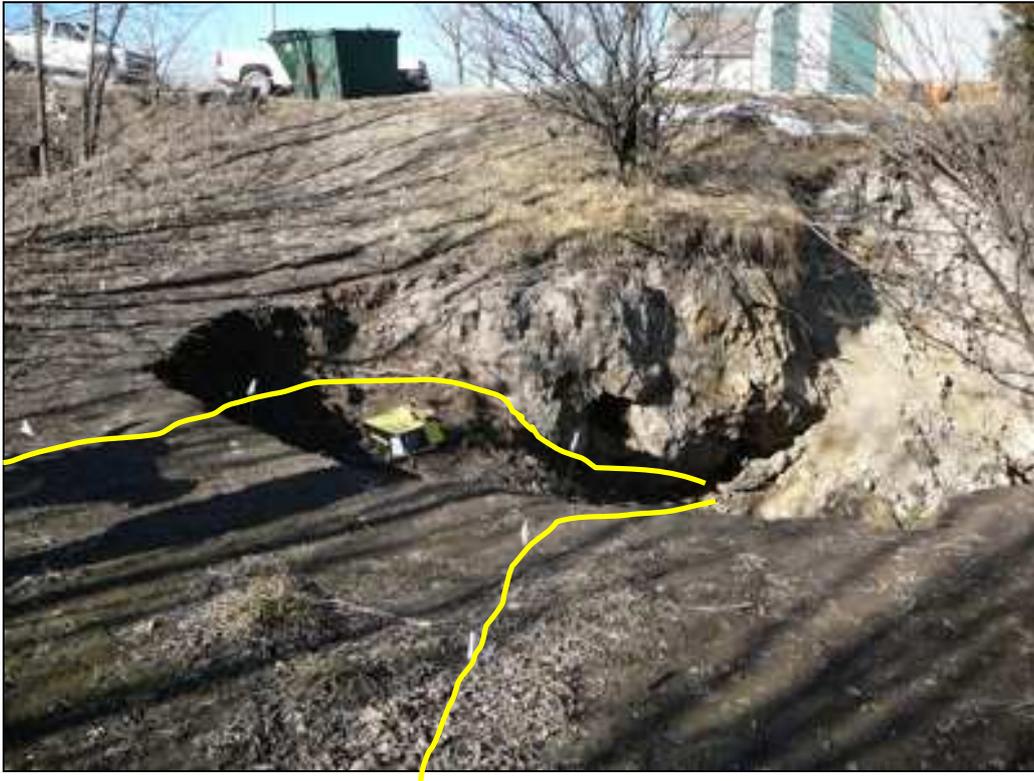
Figure 4.11 Paleosink 1 and Fracture 1 (yellow outline) in 2009. Photo facing north. Note the white pin flags in the lower left corner of the picture that were placed to monitor expansion of Fracture 1.

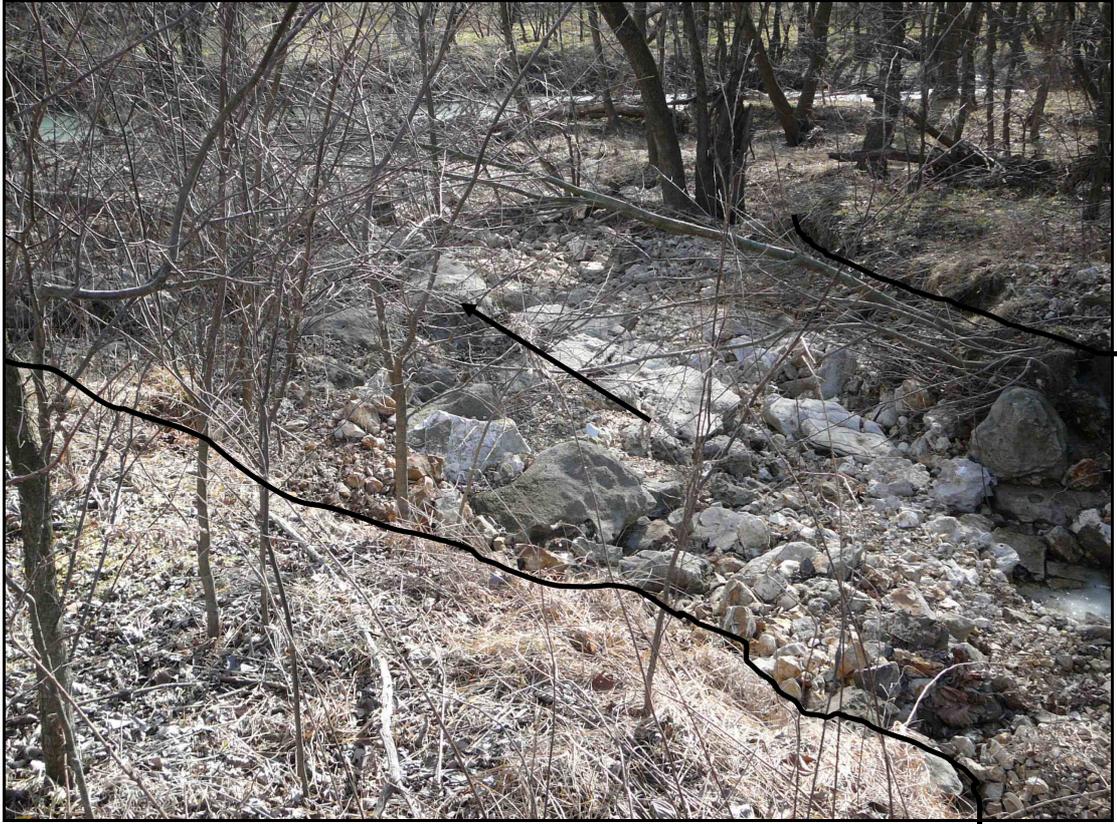
Figure 4.12 Fracture-2 leading to Youngs Creek to the southeast (black arrow).

39.5 meters (130 feet) long. It contains chert gravels and limestone boulders extending from the dam of the former lake to the edge of Youngs Creek (Figure 4.12).

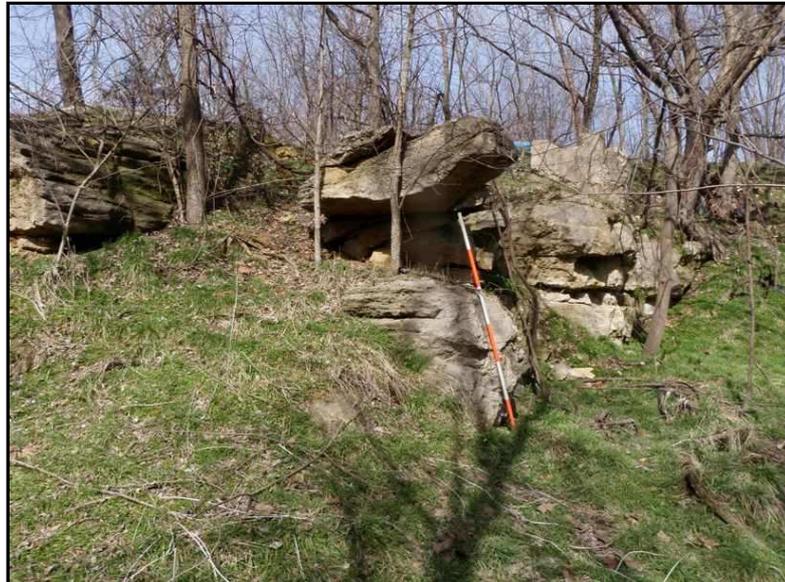
Figure 4.13 Outcrop 1 along the north bank of Youngs Creek. Photo taken facing northeast.

This outcrop stretches 70.1 meters (230 feet) along the north bank of Youngs Creek in the southeast corner of the site (Figures 4.1 and 4.13). The outcrop consists of Mississippian-age Burlington Limestone (Figure 4.14). The bedrock is identical to that observed in Paleosink 1 and Outcrop 2.

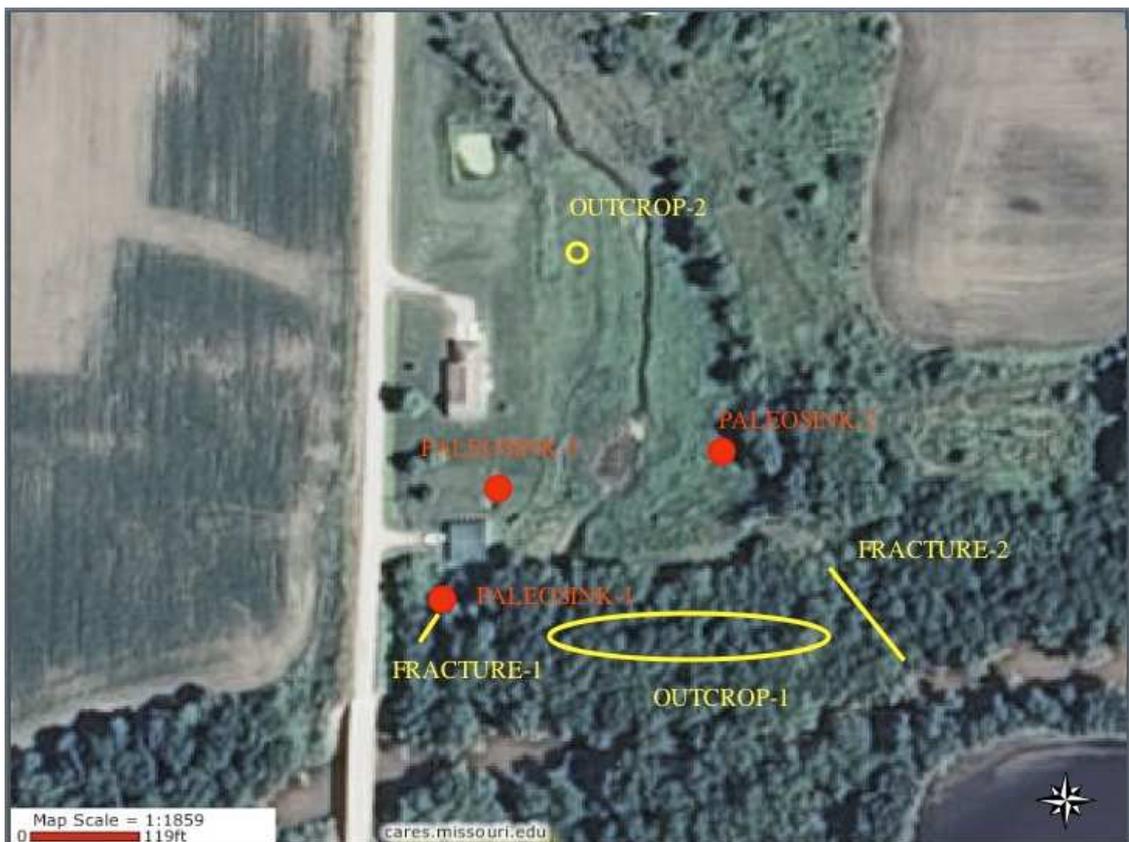
Figure 5.1 Map of the major geologic features at the ACPS. Red circles are paleosinks. Yellow circles are outcrops. Yellow lines are fractures.

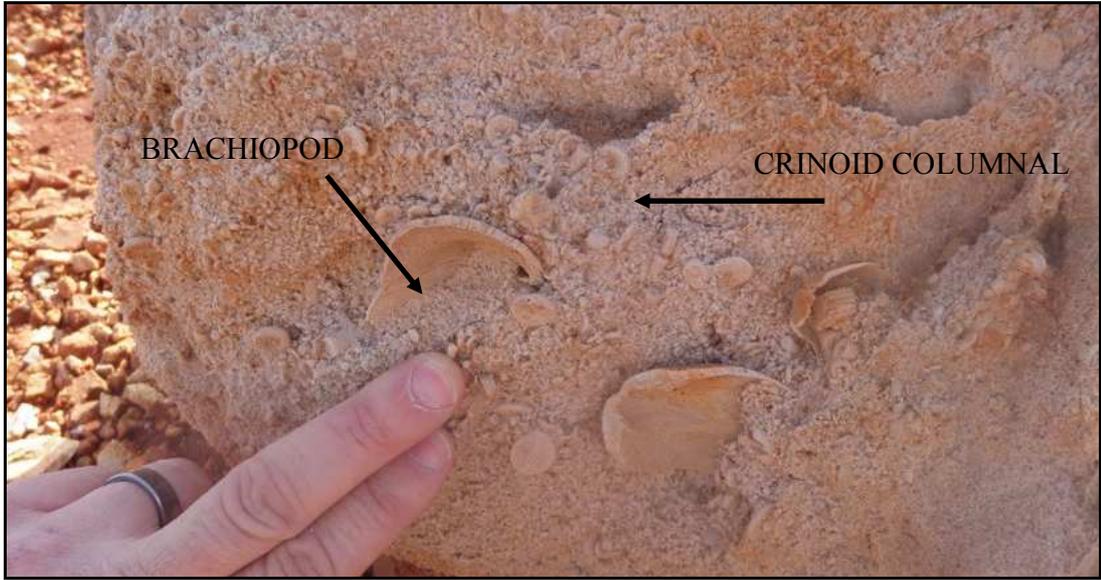
Figure 5.2 Sample of typical Burlington Limestone, southwest Missouri. It mostly consists of crinoid columnals. This sample also has large brachiopod fragments, as well as small trilobite ossicles.

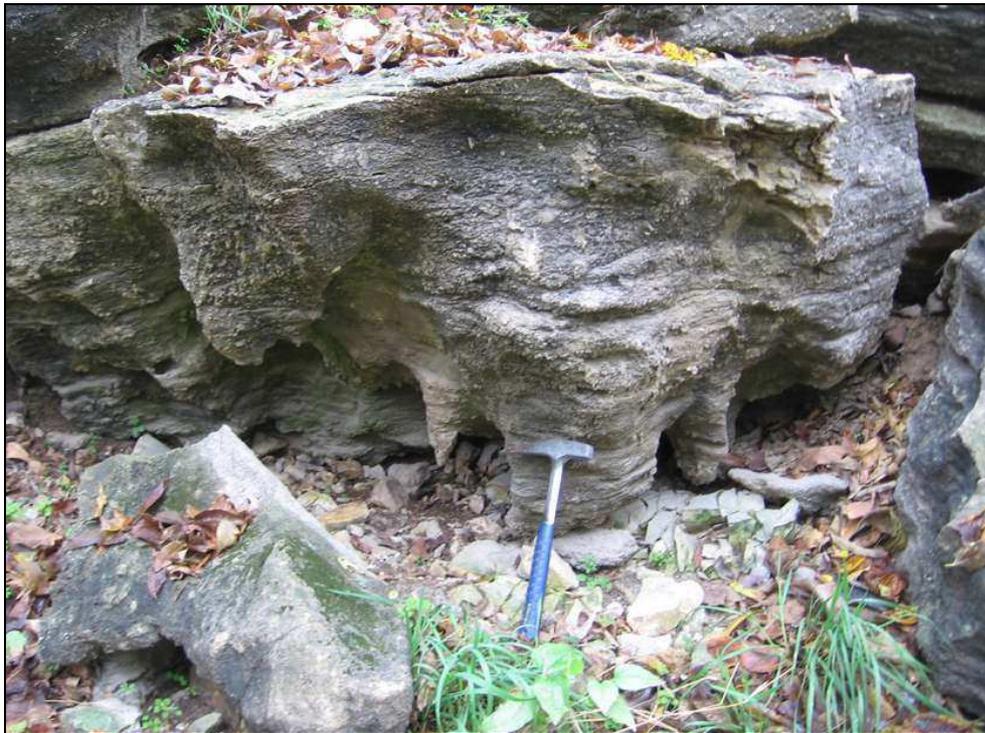
Figure 5.3 Burlington Limestone from Outcrop-1. Note the weathered limestone pendants, indicating downward vertical movement of groundwater undersaturated with respect to calcite.

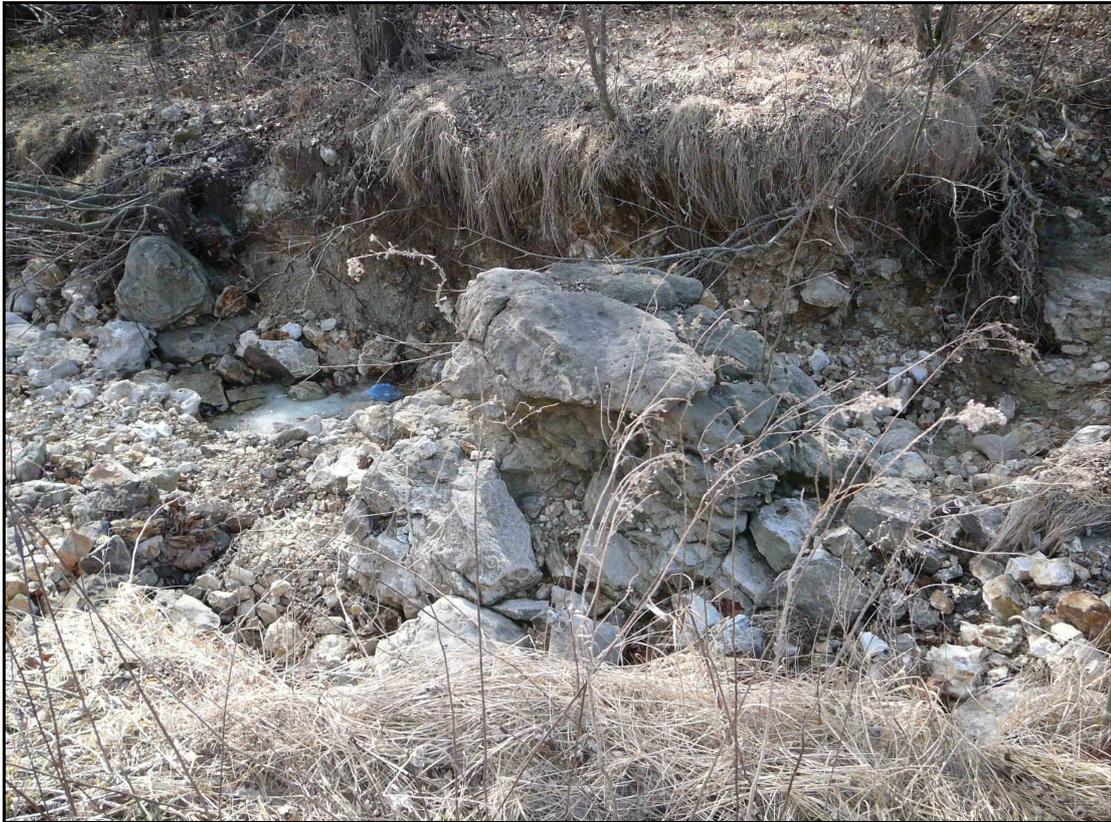
Figure 5.4 Limestone boulder and chert gravel from Fracture 2. Lithologic material is the same as bedrock and chert gravels observed in Paleosink 1.

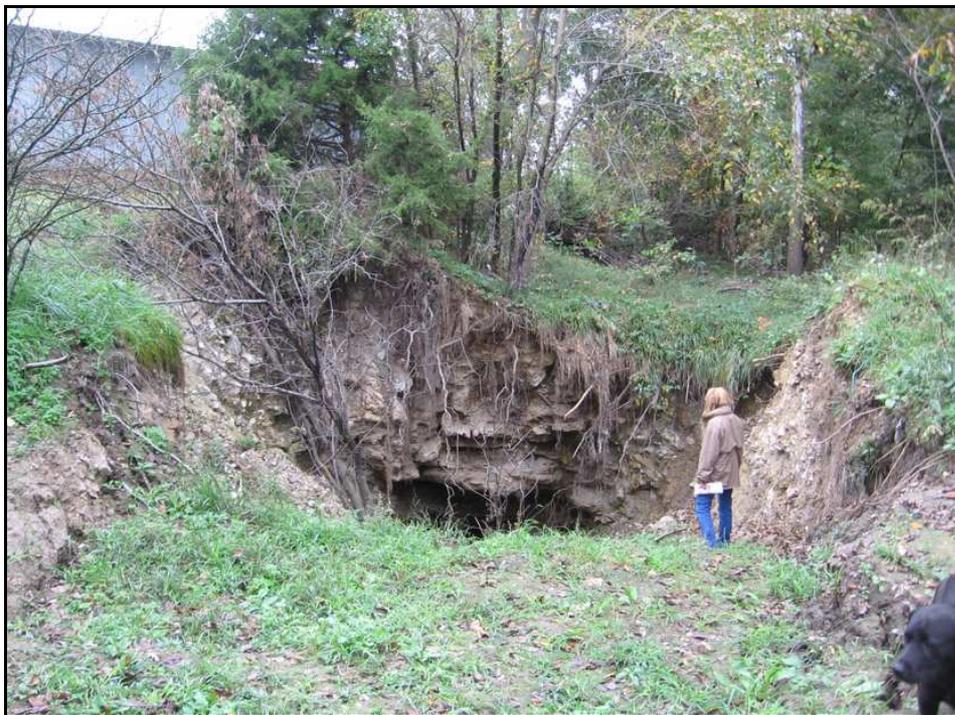
Figure 5.7 Fracture 1 in 2008.

Paleosink 1 and Fracture 1 are two inter-related subsidence features that propagate from the same subsurface karst fracture (Figure 5.7). The surficial materials within Fracture 1 dip approximately 10 degrees to the northeast into the opening of Paleosink 1, then increase to approximately 30 degrees along the same strike, to the swallet of Paleosink 1.

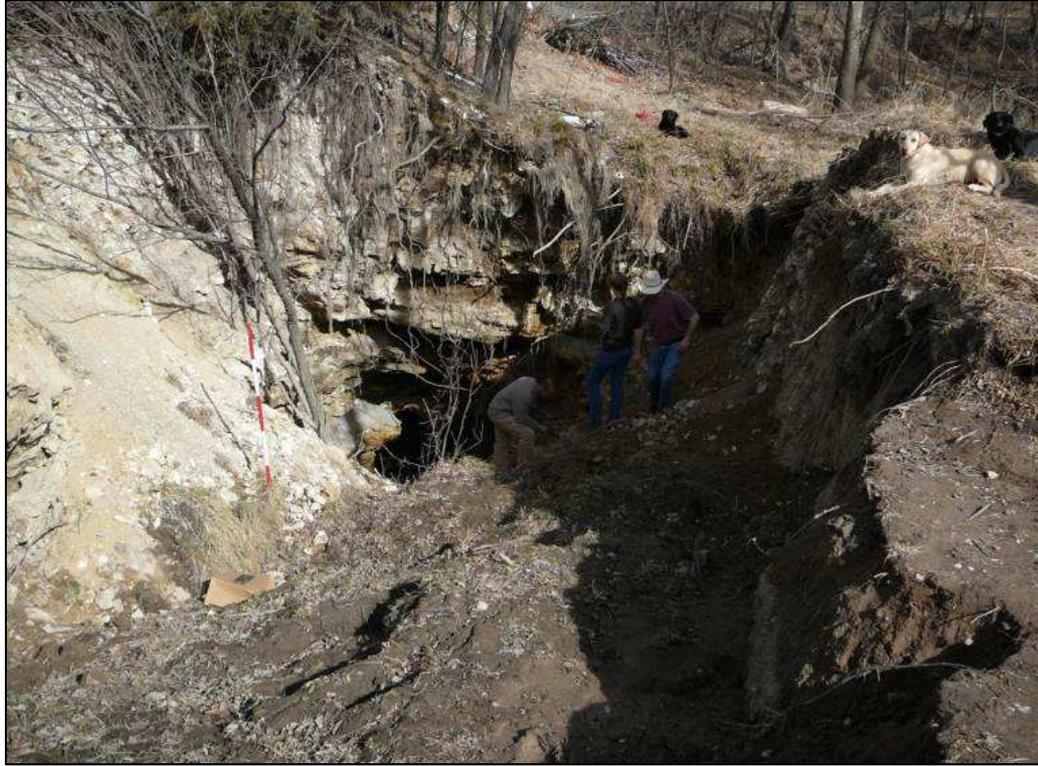
Figure 5.8 Fracture 1 in 2009. Note the subsidence in the floor of the fracture compared to the previous photo taken in 2008.

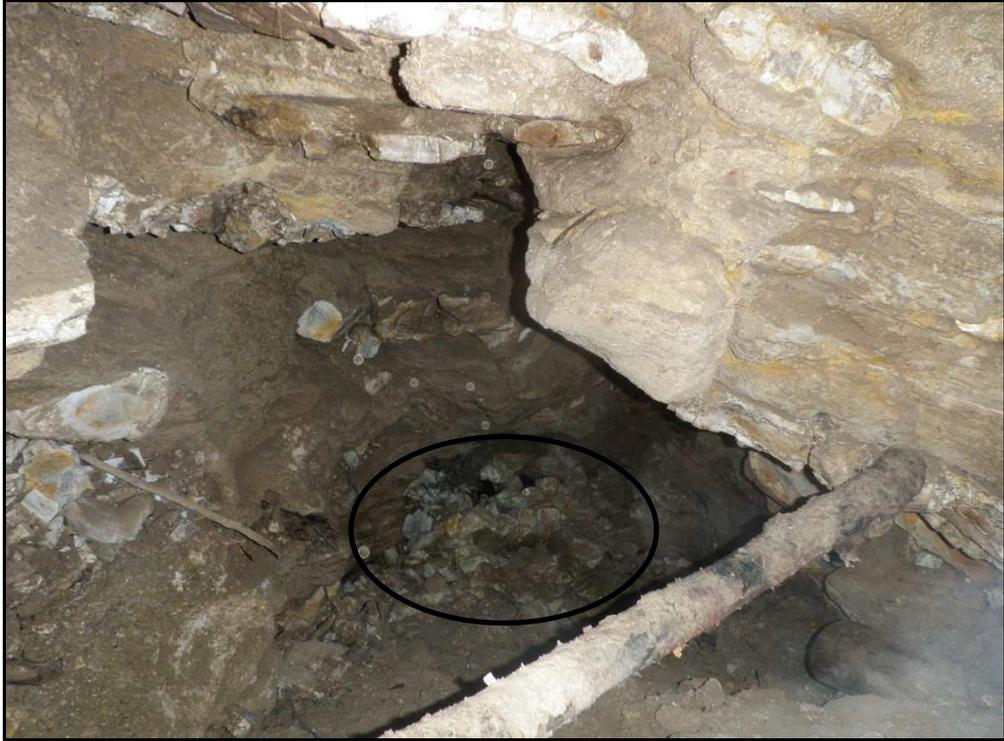
Figure 5.9 The swallet at the base of Paleosink 1. Note the log in the photo, indicating surface material falling into the paleosink.

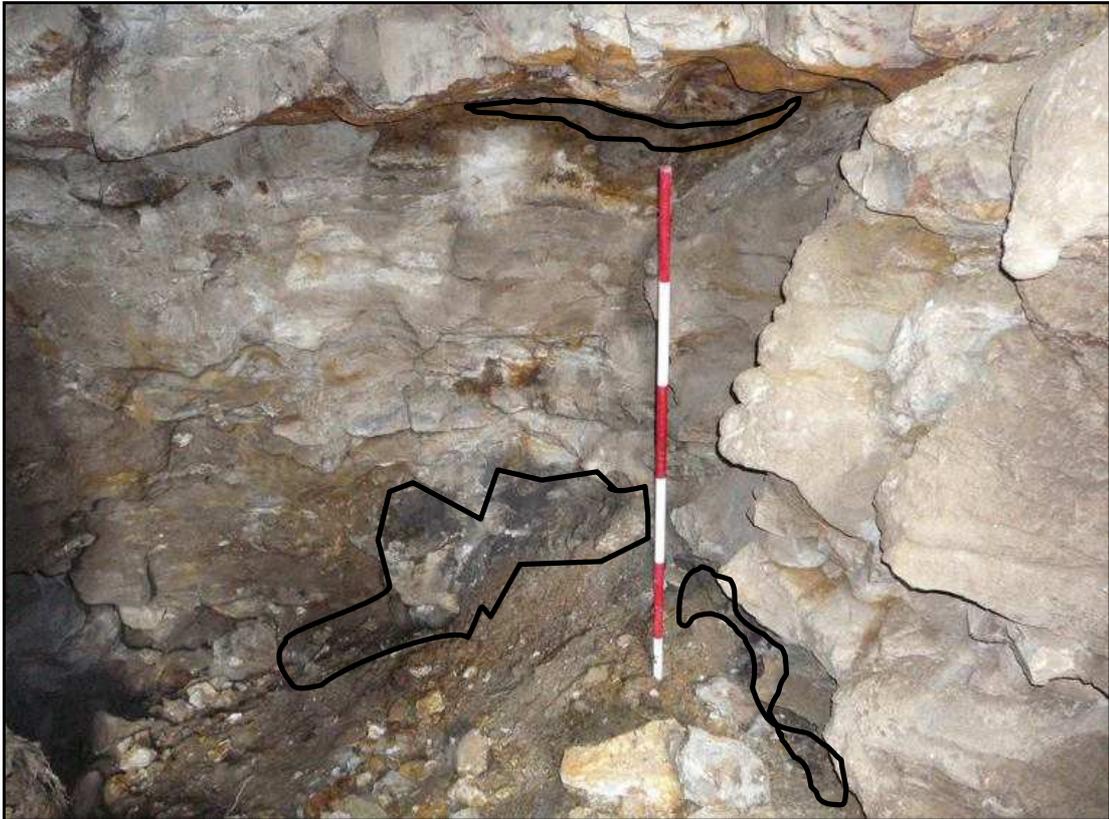
Figure 5.10 Southeast wall with zones of black weathered shale. It is unknown whether this is carbonaceous or reduced material. Similar black shale was observed in paleosink features 103 kilometers (64.28 miles) to the southwest of the site. Uppermost black shale is surrounded by ferric mineralization.

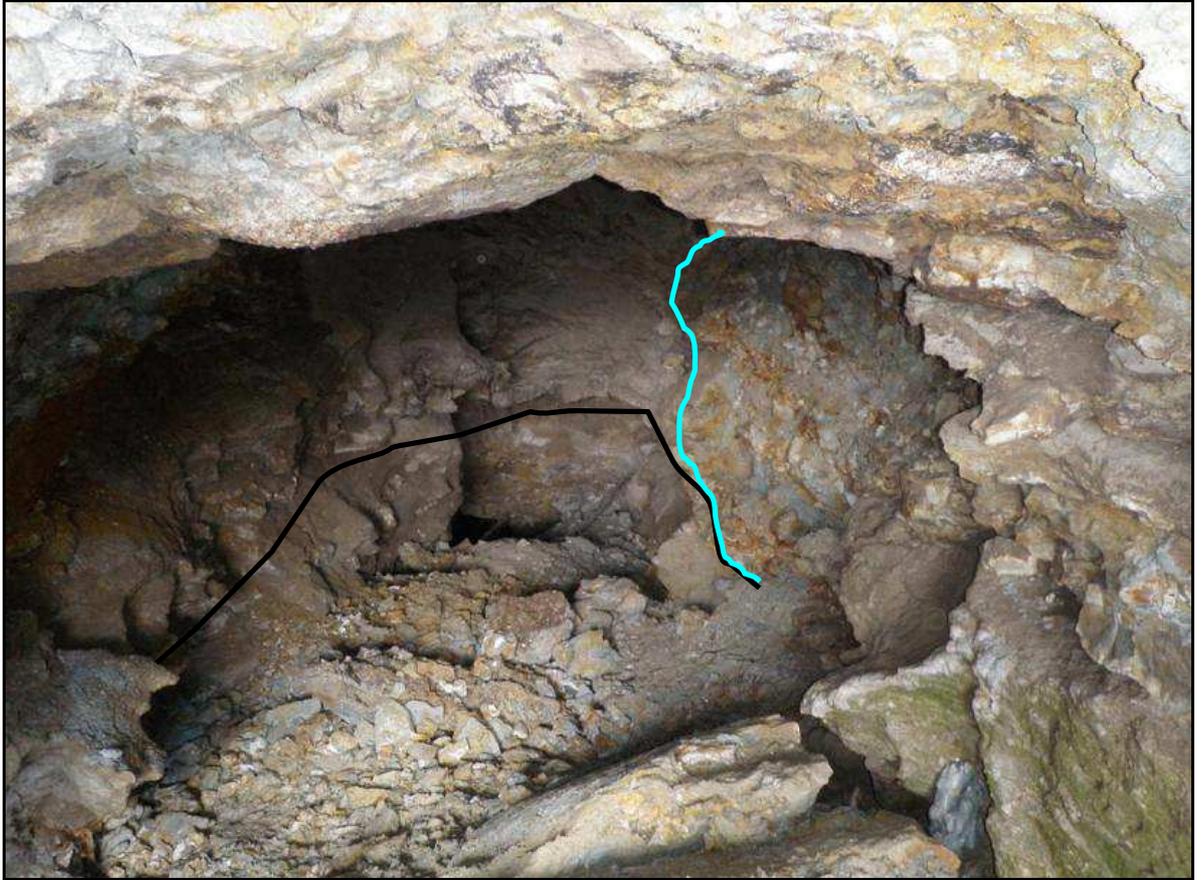
Figure 5.14 Opening of Paleosink 1. The black line follows the base of a chert bed that forms a bench above the swallet. The blue-green line marks the edge of a brecciate zone in the southeast wall.

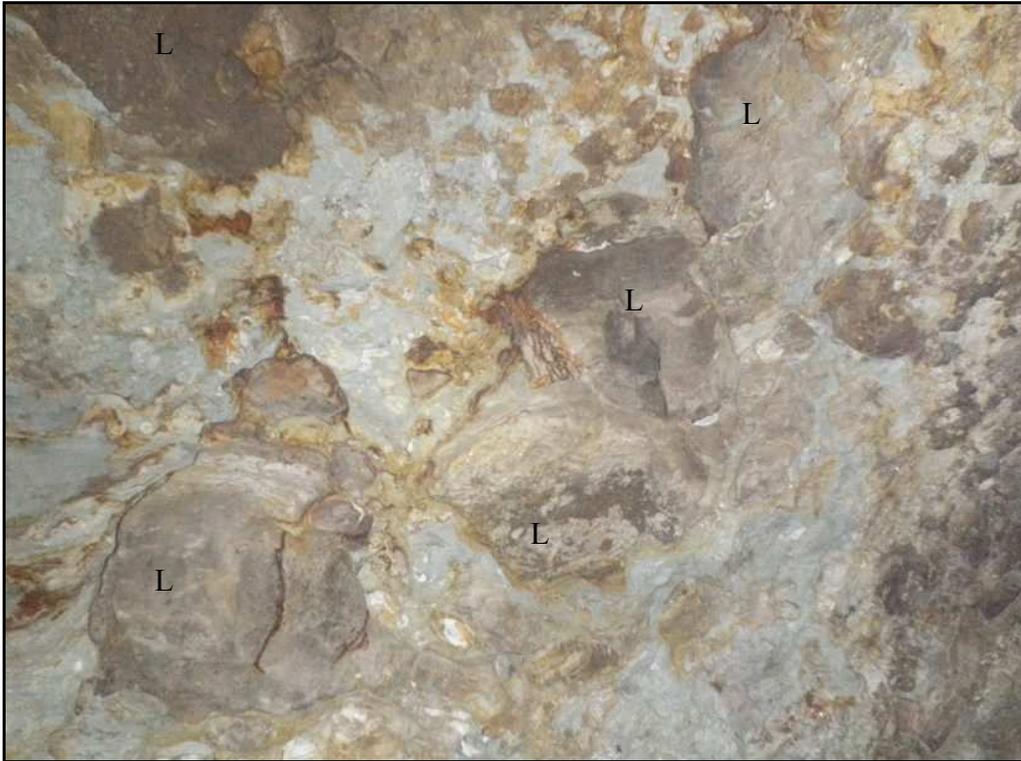
Figure 5.16 Limestone (L) boulders embedded in the residual clay of the roof of Paleosink 1. Note the oxidation of iron minerals in the reduced residual clay. The reduced clay indicates saturation, whereas the oxidation indicates acidic groundwater infiltrating the reduced clay from above. This material is identical to that observed in Fracture 2 to the east, sans the clay residuum.
