**Reactivated Paleokarst in Northern Audrain County,
Missouri**

A Thesis

Master of Science

James Blake Smotherman

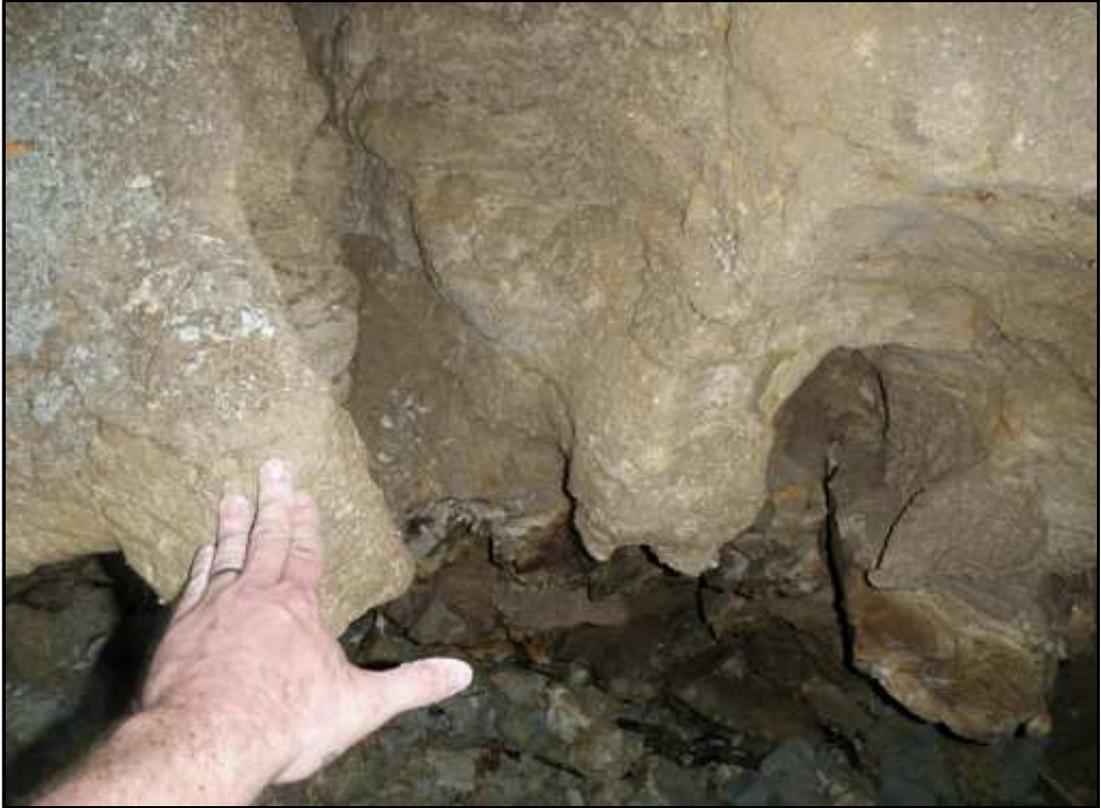
Figure 5.17 Solution-weathered pendants, indicating downward movement of groundwater undersaturated with respect to calcite.

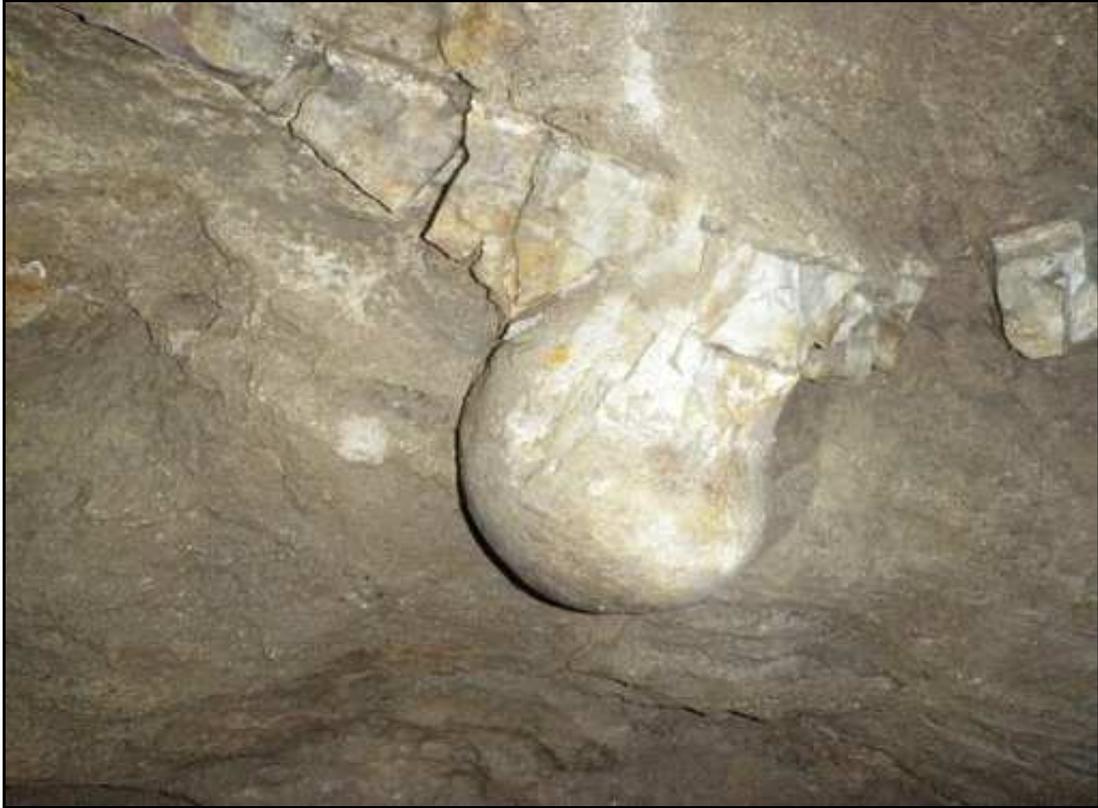
Figure 5.18 Chert lens in Paleosink 1. The chert has replaced the limestone during diagenesis. Soft-sediment deformation during diagenesis is indicated in the bend in the chert bed to the right of the photo. Nodular feature is unique to this lens.

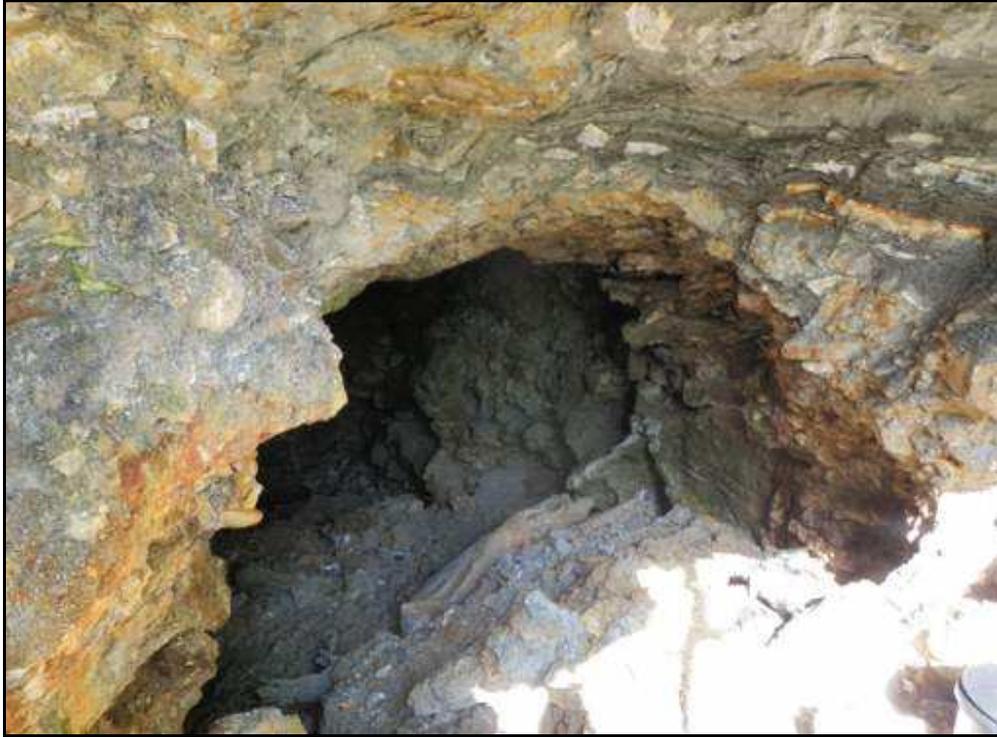
Figure 5.19 Paleofill at the entrance of Paleosink 1.

In 2011, the opening was measured at 3.9 meters (13 feet) from wall to wall, and 1.7 meters (5.7 feet) tall. Investigations revealed a deposit of claystone and shale, with beds and lenses of quartzose sandstone, forming the archway (Figure 5.19). The sandstone had a small percentage of angular, white chert particles within it that were identical to the chert observed in the shale and the Burlington Limestone. Angular chert

Paleofill observed at the entrance of Paleosink 1 consisted of alternating bands of shale, claystone and sandstone (Figure 5.19). The sandstone was composed of grains of chert and quartz sand. Chert clasts from the Burlington Limestone had been incorporated into the shale (Figures 5.20 and 5.25). Slight soft sediment deformation was present in the layers and the chert clasts included in the shale (Figures 5.20 and 5.24).

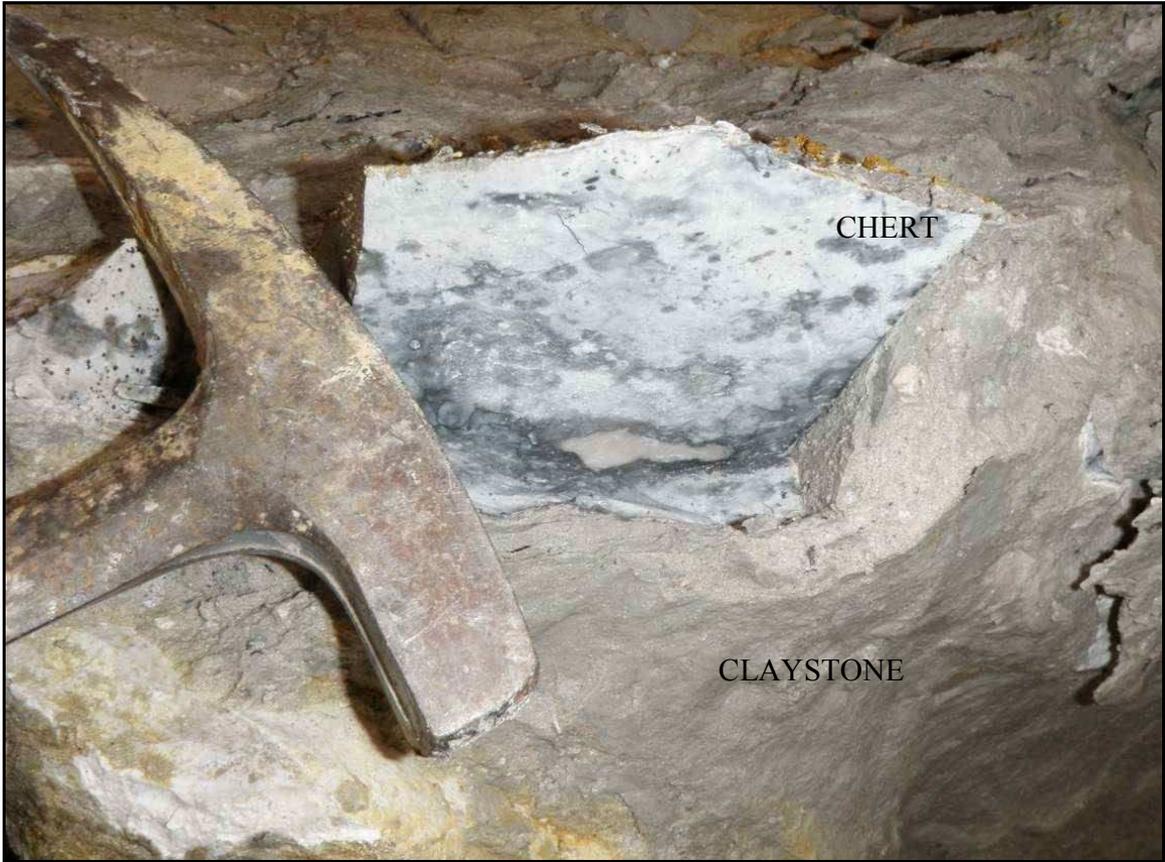
Figure 5.25 Chert clast typical of the Burlington Limestone at the ACPS. The chert clast is hosted in a weakly consolidated claystone.

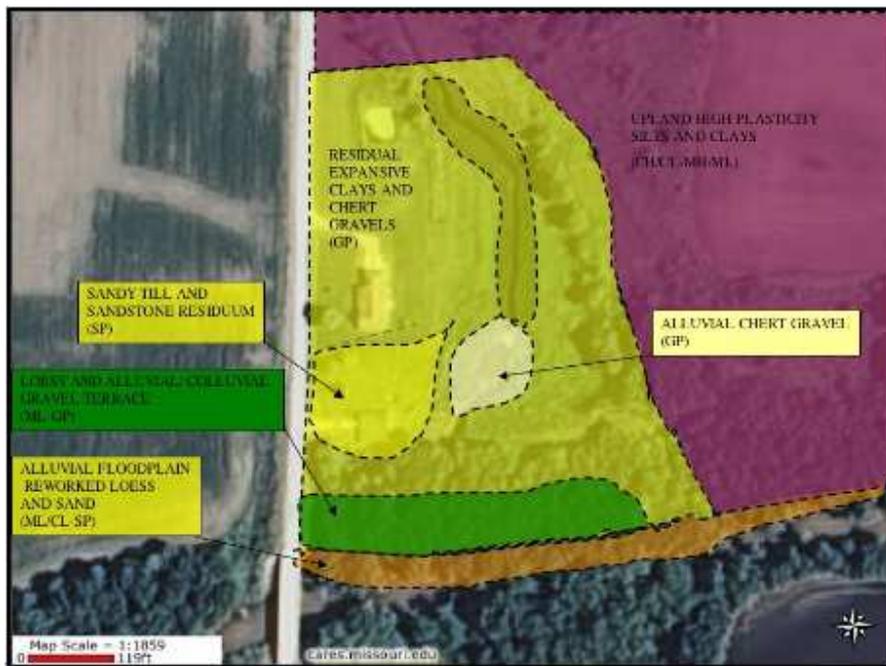
Figure 5.27 The distribution of surficial materials across the ACPS. USCS field classifications were used.

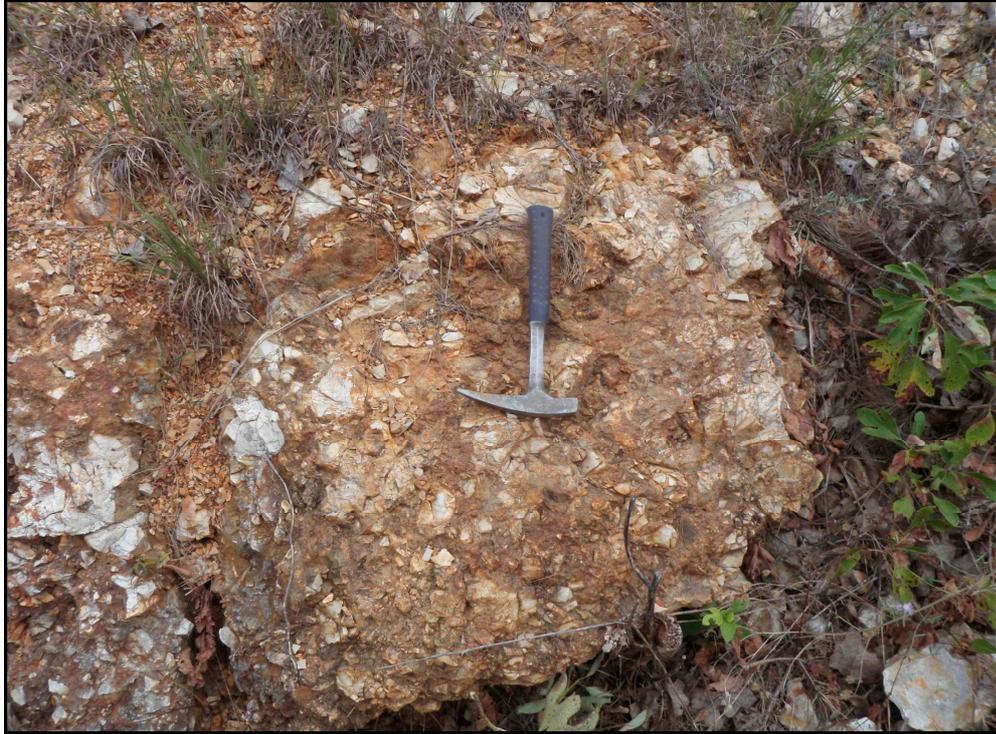
Figure 6.3 Boulder of Pennsylvanian-age Graydon Conglomerate, basal Cheltenham, southwest Missouri.

In southwest Missouri, the Graydon Conglomerate is the basal member of the Cheltenham (Figure 6.3). In this area, it consists of reworked Burlington chert within a hematitic sandstone conglomerate. Geologic maps and surface outcrops of the Graydon indicate that it occurs as thin deposits and can occupy varied depositional environments such as paleokarst, paleo-stream channels and graben structures. The Graydon cherts and sands are well rounded and poorly sorted, indicating a high energy, short distance transport not dissimilar to the streams of the Ozarks today. This could indicate high gradient streams flowing off of the Ozark Plateau during the Pennsylvanian, then being deposited in channel fill, sinkholes and shallow marine graben structures.

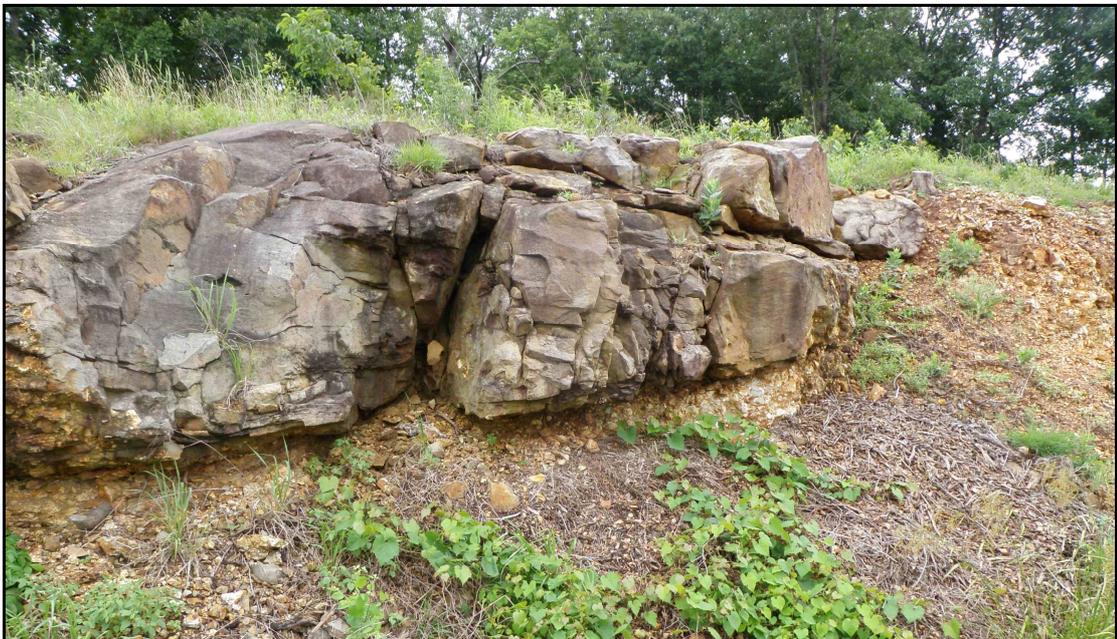
Figure 6.4 Pennsylvanian-age Warner Sandstone overlying Graydon Conglomerate, west-central Missouri.

The Warner Member of the Cheltenham Formation is prevalent in central Missouri (Figure 6.4). This member typically consists of sands with some chert gravels deposited as laterally extensive, thick sheet deposits along the northern edge of the Ozarks Plateau. The immense amount of sand indicates a significant, nearby clastic source, such as the weathering of the Ordovician-age St. Peter Sandstone.

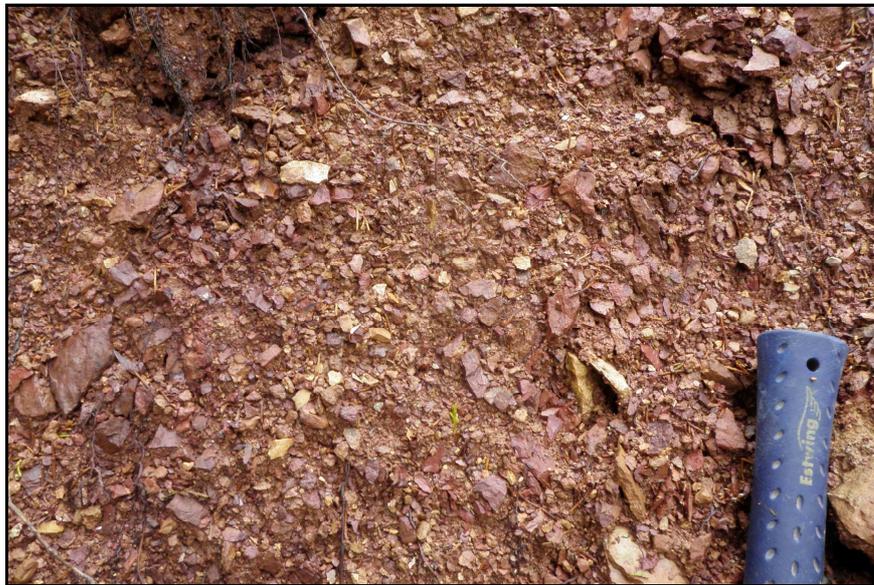
Figure 6.5 Pennsylvania-age Cheltenham Formation. This red shale is interpreted as residual terra rosa clay weathered off carbonates exposed during the Kaskaskia Regression, then buried and lithified into shale during the Pennsylvanian.

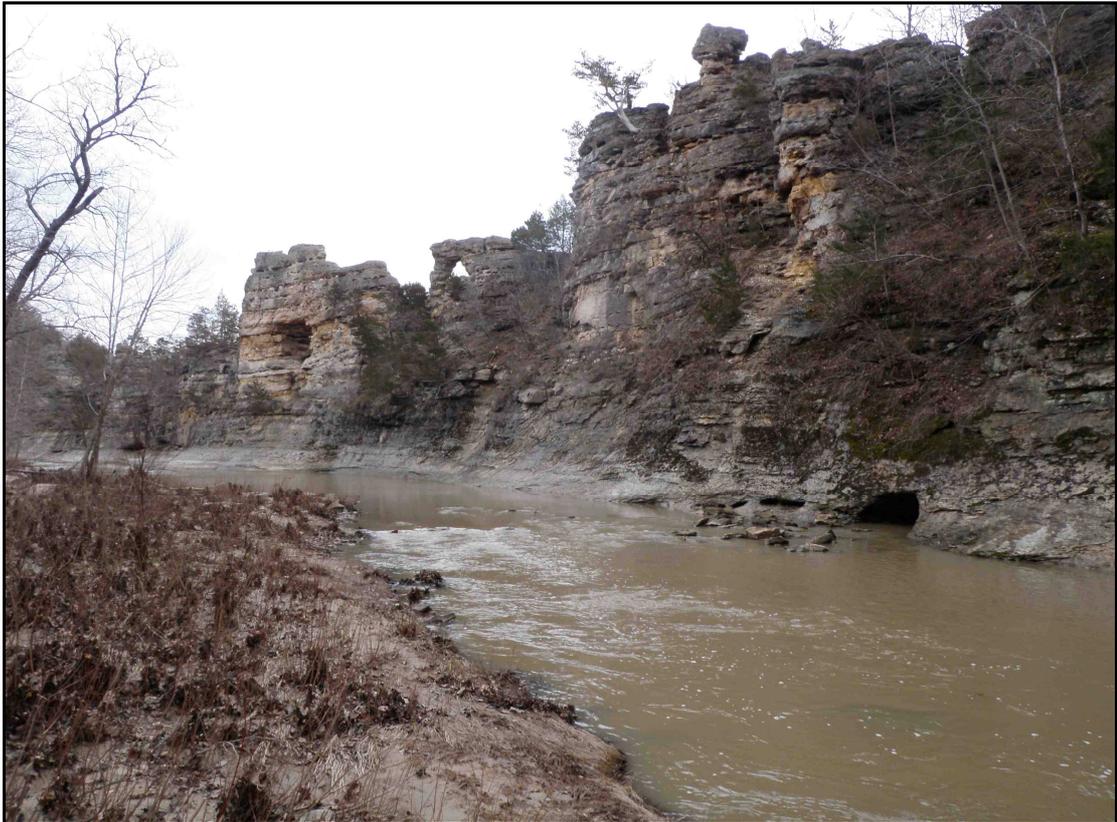
Figure 7.1 Solution-weathered features visible at Pinnacles Youth Park to the west of the ACPS.

When compared to the known karst and observable bedrock in the area around the ACPS, an elevation pattern emerges. The Pinnacles Youth Park 33.7 km (21 miles) to the west of the ACPS, is at an elevation of 243.2 meters (800 feet) mean sea level. The Pinnacles display a heavily eroded karst landform with solution-weathered fractures, conduits and caves that stands 30.4 meters (100 feet) above the gaining stream that flows around it (Figure 7.1). The ACPS is at an elevation of 224.9 meters (740 feet) mean sea
